**FUNGAL BIODETERIORATION OF CONCRETE
AND
ITS PREVENTION USING NANOPARTICLE
COATING**

A Thesis

**SCHOOL OF ENVIRONMENTAL STUDIES
JADAVPUR UNIVERSITY**

2019

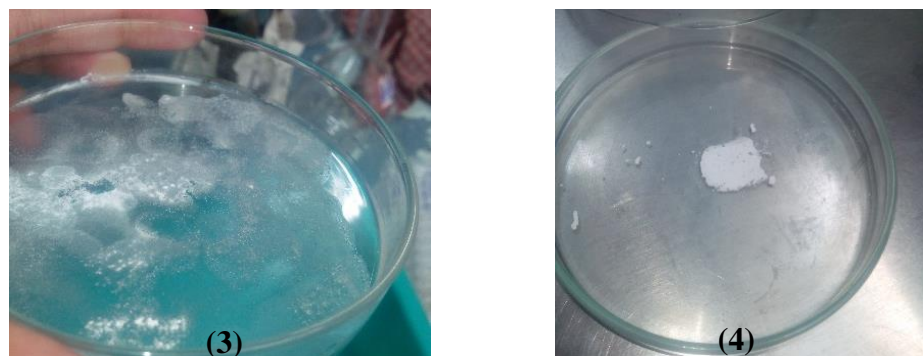
Figure 3: The 4 combinations of binder, silicon oxide nanopowder and distilled water after 48 hours of drying (1) Ratio-1 : 0.1 : 2 (2) Ratio-1 : 0.5 : 2 (3) Ratio-1 : 1 : 2 (4) Ratio-1 : 5 : 2.

Thus, the 2nd combination of binder, silicon oxide nanopowder and water (1 : 0.5 : 2) was chosen to be proceeded further in the study.

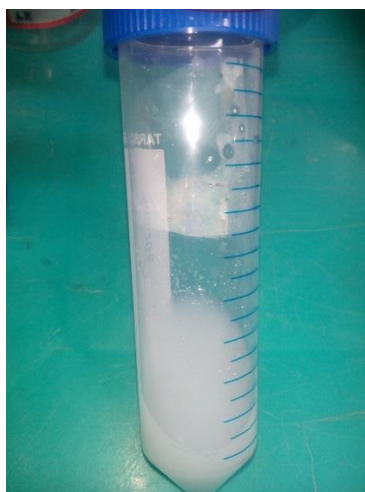
Figure 4: The aqueous milky white coloured Nanoparticle coating after the mixing of the binder, nanopowder and water.

For the study; 25 ml binder, 12.5 g Silicon oxide nanopowder and 50 ml distilled water were mixed and sonicated for 5 minutes (avoiding froth formation on the surface) at room temperature. A milky white homogenous solution of nanoparticle coating was obtained.

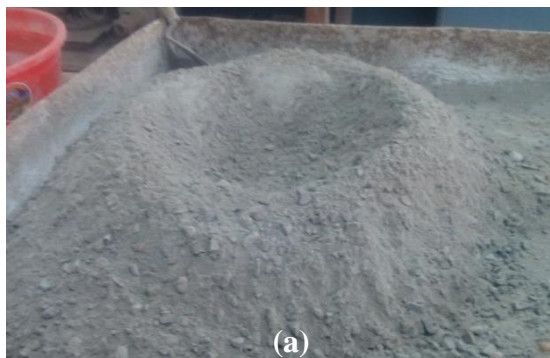
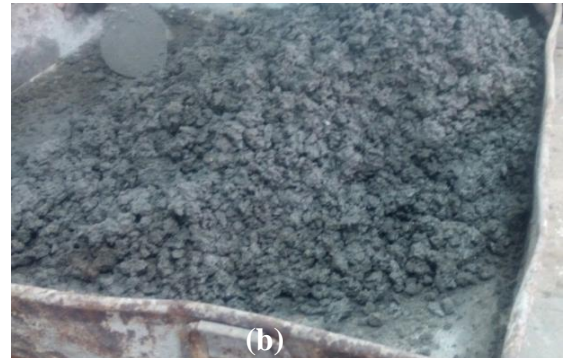
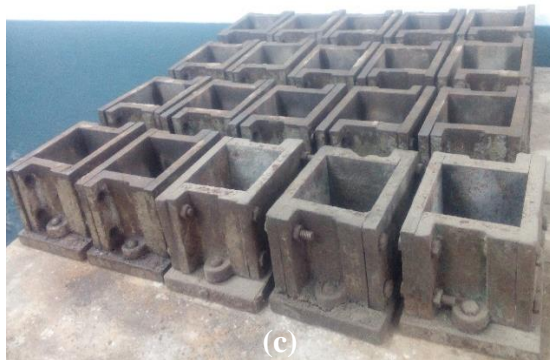
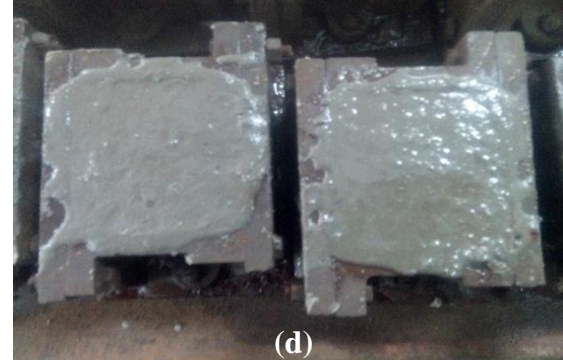
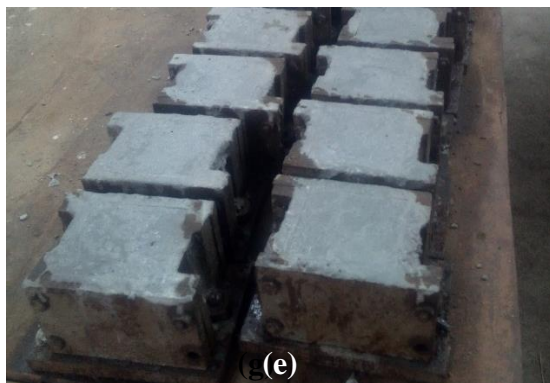
Figure 5: Concrete Cubes preparation : (a)Cement, sand and stone chips mixed in a ratio of 1: 1.5 :3 (b)Water added to obtain the concrete mix (c)Cubic cast iron moulds (d)Concrete poured and leveled in cast iron moulds (e)After drying overnight (f)Cubes submerged in water for curing of 28 days (g)Concrete cubes after curing and 3 days of drying.

After 24 hours, the moulds were removed and solid concrete cubes of dimension 7 cm x 7 cm x 7 cm were obtained. These cubes were then submerged in clean water for 28 days for curing. Having gained the maximum strength, the cubes were taken out of water and dried for 3 days at room temperature. The initial weights of the cubes were recorded in a weight balance followed by the measurement of their initial compressive strength.

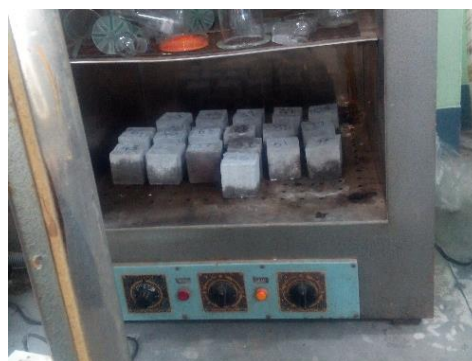
Figure 6: Nanoparticle coated Concrete Cubes in hot air oven after 4 days of drying at 40°C.

The cubes that were selected for the study of prevention of fungal biodeterioration were brushed uniformly with the previously prepared Silicon oxide nanocoating. These cubes were then kept in the hot oven dryer at 40°C and were dried for 4 days.

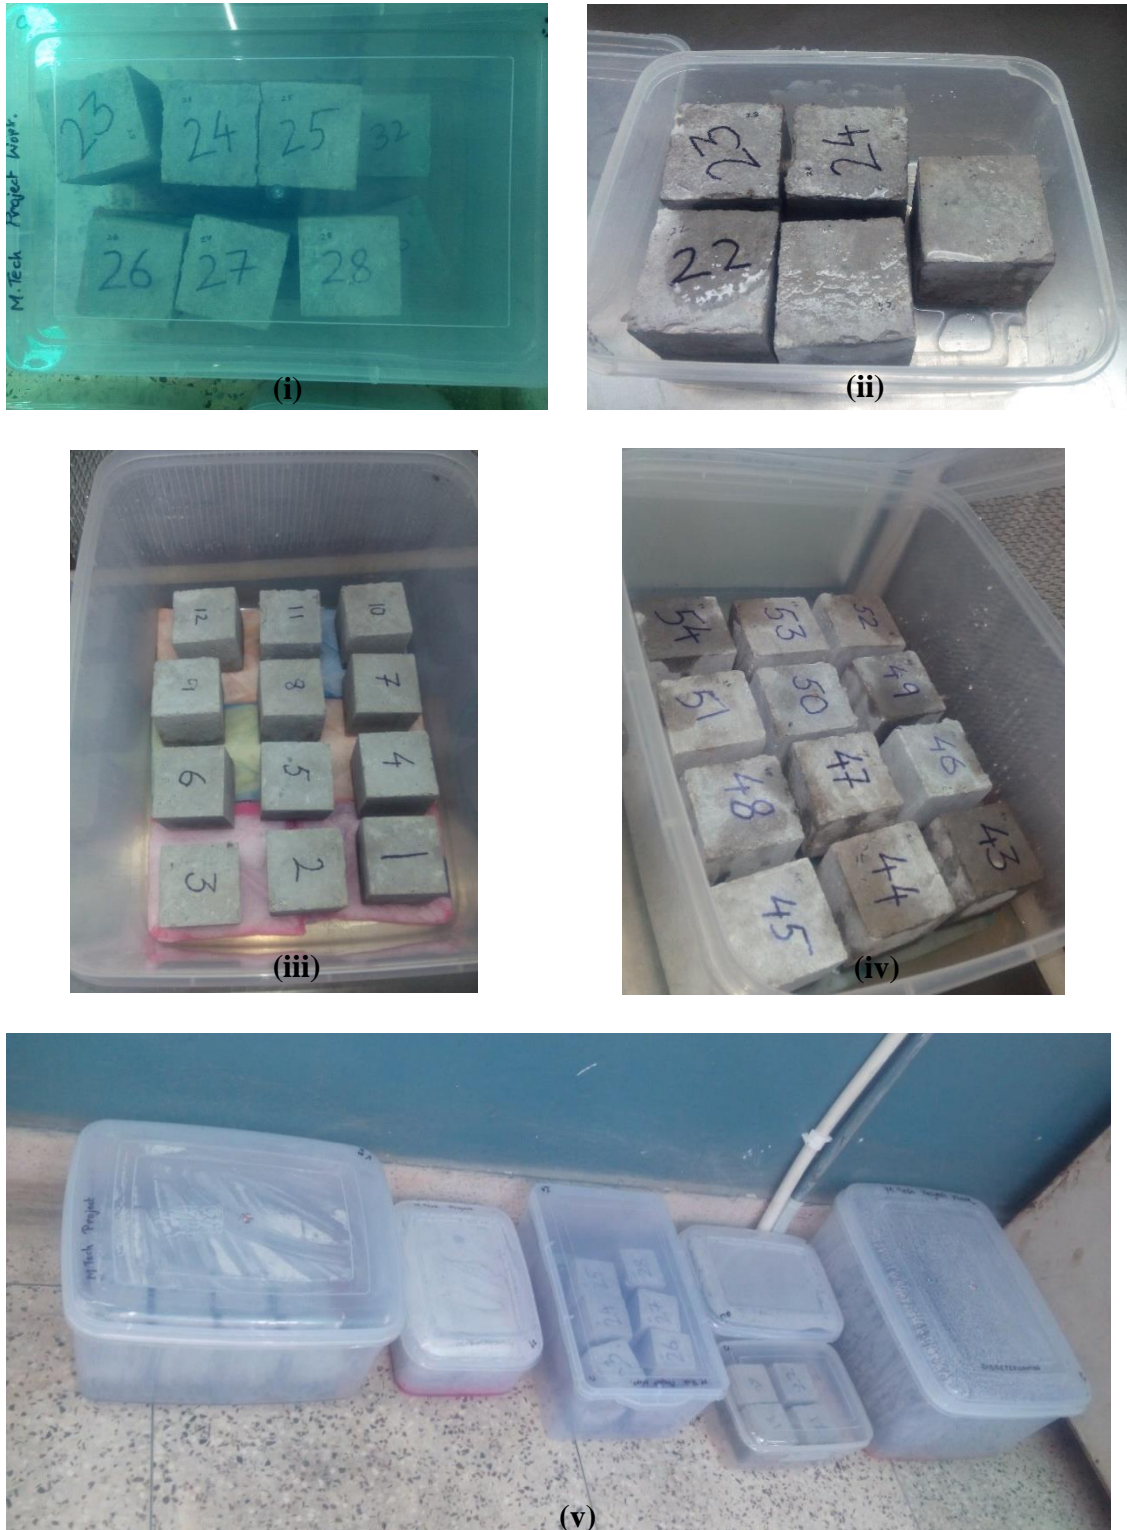
Figure 8: (i)Control set-up (ii)Positive Control set-up (iii)Biodeterioration set-up (iv)Prevention set-up (v)The Final Experimental Set-up arrangement.

This experimental setup was kept at room temperature for 6 months and after every month, cubes from each set were removed and tested to observe the changes.

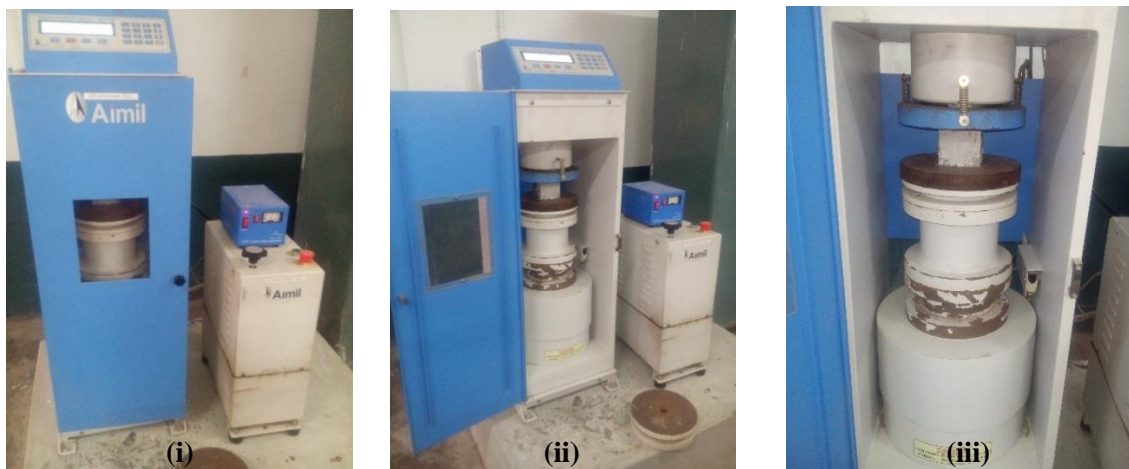
Figure 12: (i) and (ii) :Universal Compressive Strength Test Machine (iii) Concrete cube placed between the spherical plattens for strength test.

$$\text{Compressive Strength of Concrete (N/mm}^2\text{)} = \frac{\text{Maximum Load applied to the cube}}{\text{Cross-sectional Area of the cube}}$$

During the compressive strength test, all the concrete cubes were found to be collapsed and broken. Small pieces of concrete were then collected from these broken cubes to be further tested and analyzed in various other sophisticated instruments.

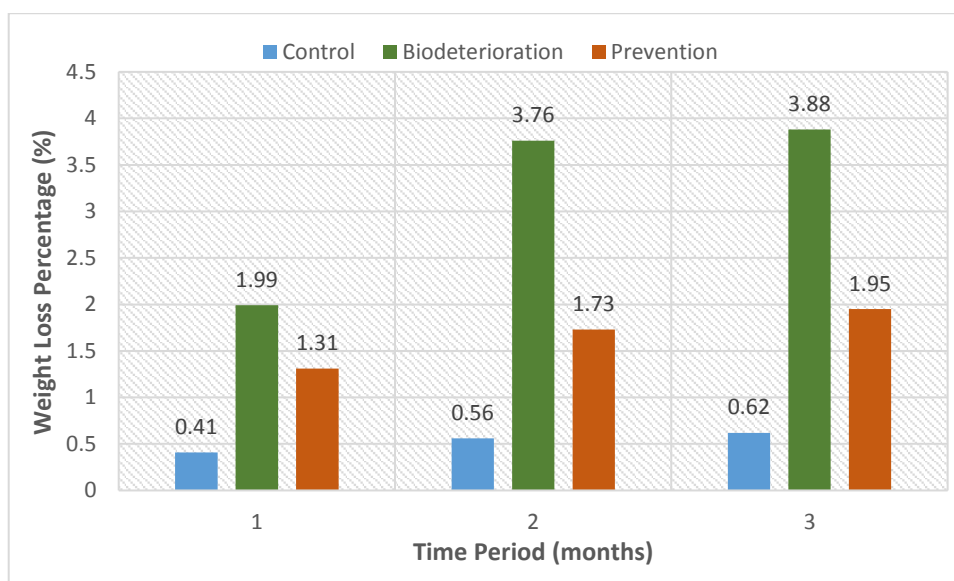
Figure 20: Comparison of Weight Loss Percentage (%) between control, biodeteriorated and nanocoated concrete pieces.

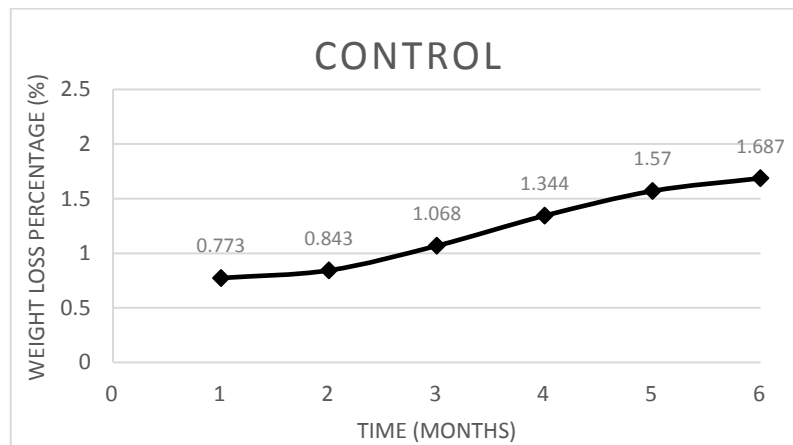
Figure 22: Weight loss Percentage (%) with Time (months) for concrete cubes of Control set-up.

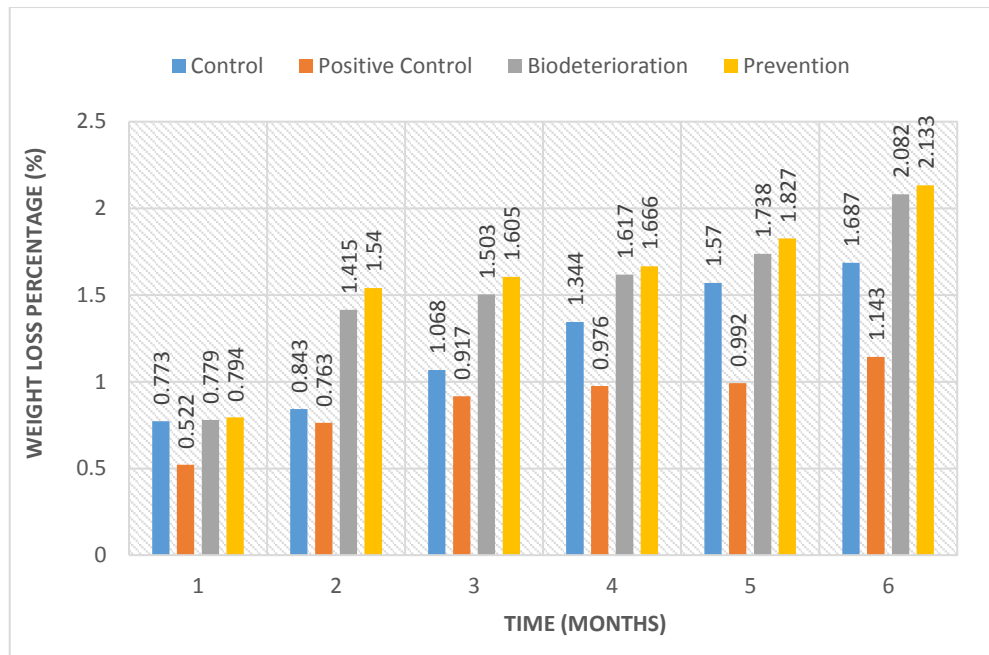
Figure 26: Comparison of percentage weight loss (%) with time (months) of concrete cubes from the respective experimental set-ups.

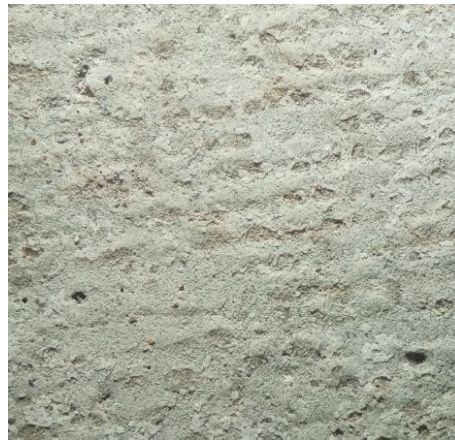
Figure 27: Stereo microscopic image of concrete cube surface from the control set-up.

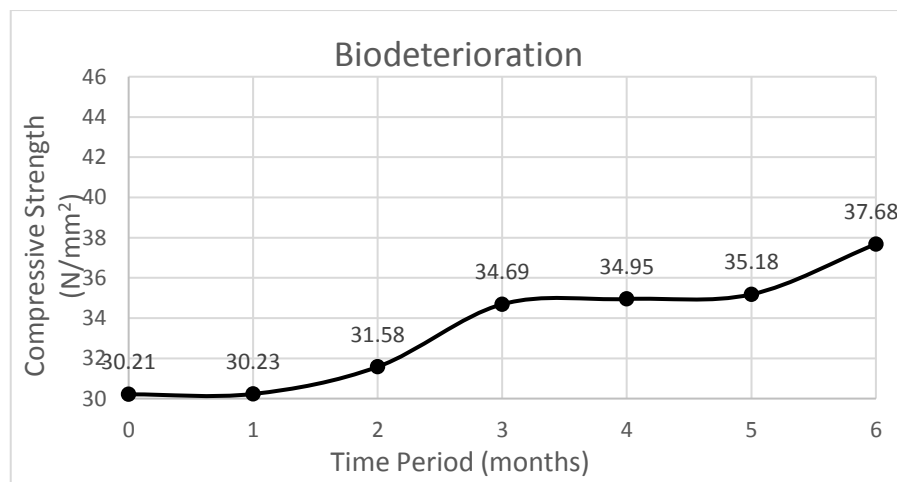
Figure 32: Compressive strength of biodeteriorated concrete cubes with respect to time.

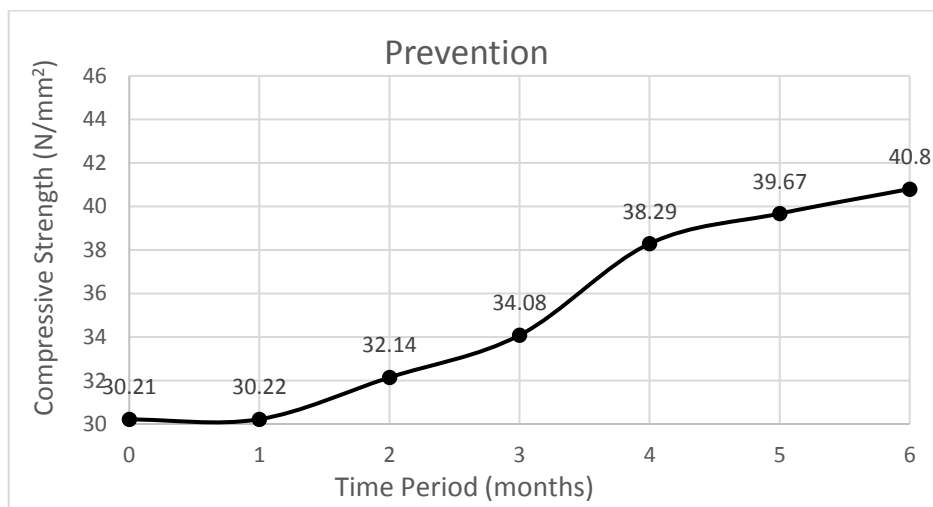
Figure 33: Compressive strength of nano-coated concrete cubes with respect to time.

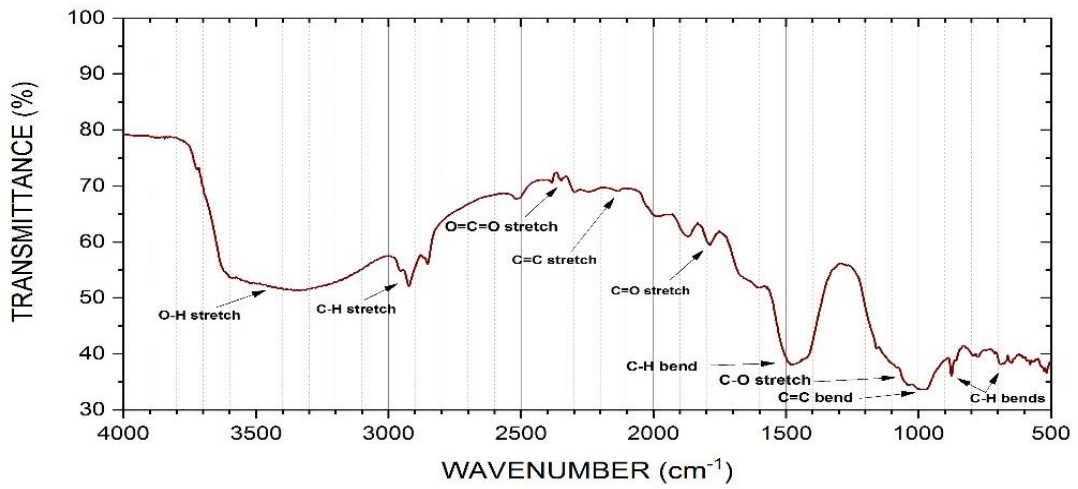
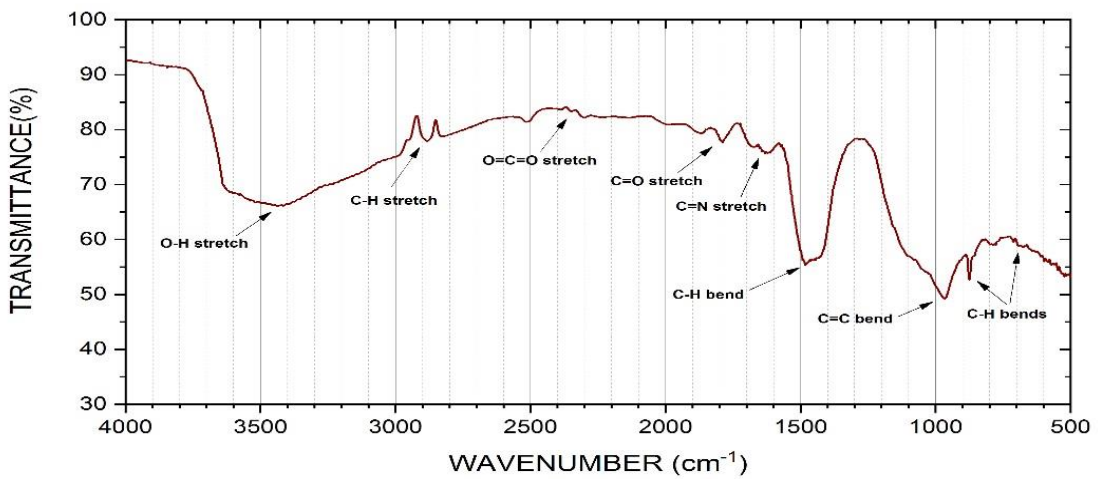
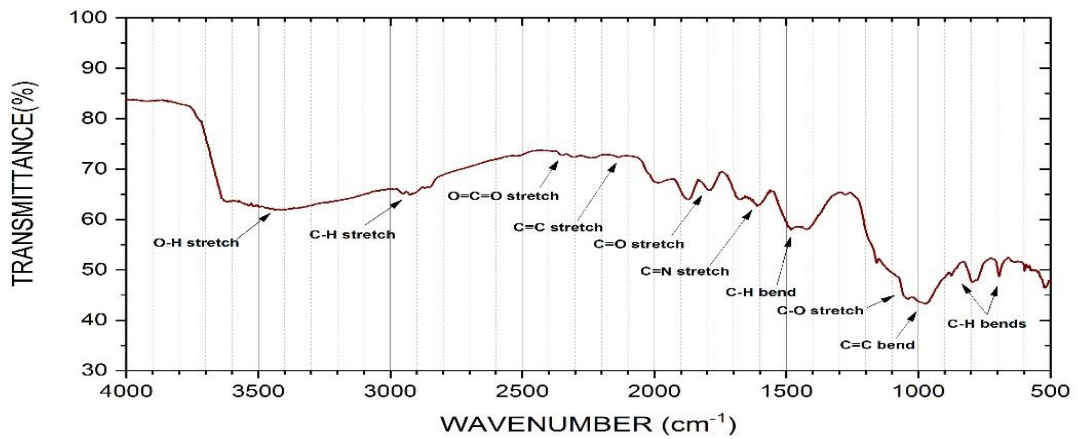
Figure 40: IR transmittance spectrums of concrete for prevention set-up.

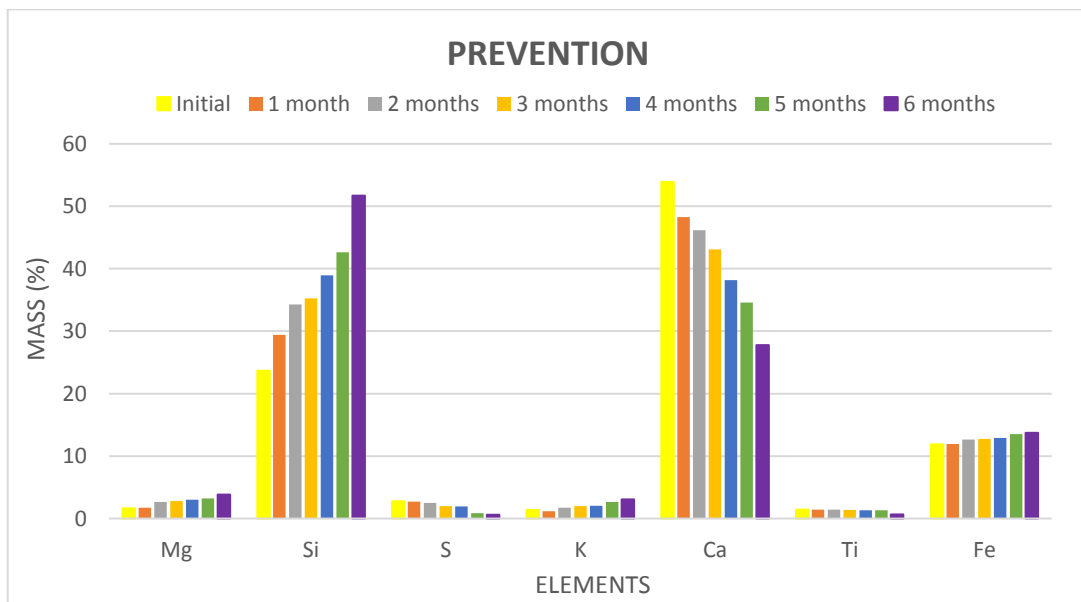
Figure 42: Mass percentage of different elemental contents of nanocoated concrete cubes.
