**Corrosion Distress Mapping of Real Life RCC Building  
Structure Adopting Extensive Non-Destructive Test  
Data and Their Correlation**

**MASTER OF CONSTRUCTION ENGINEERING**

**STRUCTURAL REPAIR AND RETROFIT ENGINEERING**

**JADAVPUR UNIVERSITY**

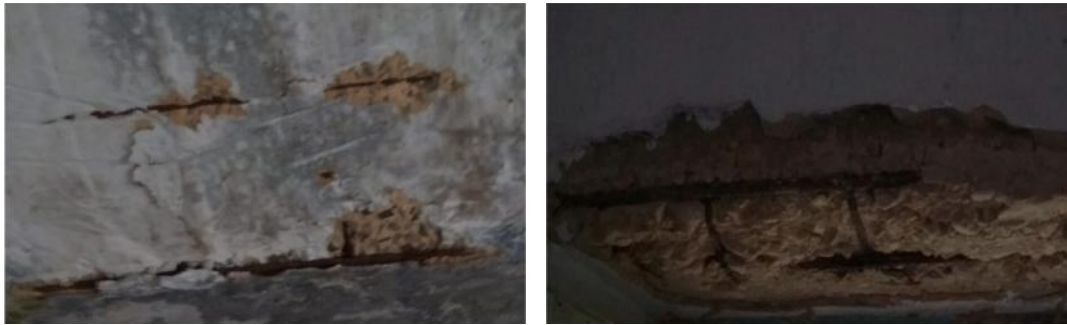
been faded away in many cases mostly due to corrosion, which may even lead to structural failure. Cracking and spalling of concrete, reduction in cross-sectional area of reinforcement bars, change in elastic modulus of reinforcement as well as concrete and loss of bond between concrete & corroded reinforcement are the major outcome of distresses in concrete structure due to corrosion. The corrosion i.e. oxides of iron occupies much greater volume than the parent metal, which exerts a bursting pressure on the concrete cover and resulting in cracks and subsequent spalling of concrete. Spalling of concrete, a major cause of corrosion is shown in Fig-1.2 below.

**Fig-1.2:** Severe Corrosion leads to Spall of Cover Concrete

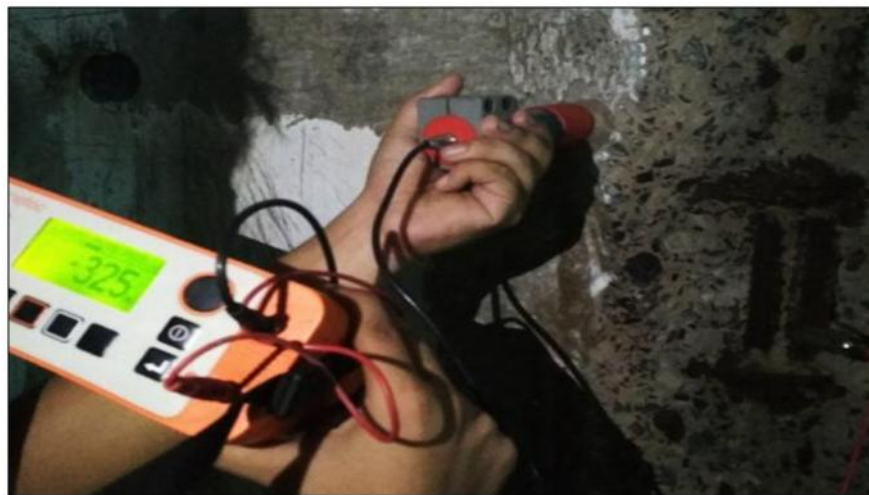
The principle of the test is to measure the difference in potential by the Half-Cell potentiometer. The simplest way to assess the susceptibility of corrosion by measuring the potential difference between a standard portable half-cell, normally copper (Cu) / copper sulphate ( $\text{CuSO}_4$ ) electrode placed on the surface of concrete with reinforcement underneath. The reference electrode is connected to the positive end of the voltmeter and the reinforcement to the negative end as shown in Fig-4.1 below. The test gives the susceptibility of corrosion activity at the point where the measurement of potential is taken place. An electrical connection is to be developed with the reinforcement and the half-cell is moved across the saturated concrete surface.

**Fig-4.1:** Half Cell Potentiometer Test to Assess the Susceptibility of Corrosion

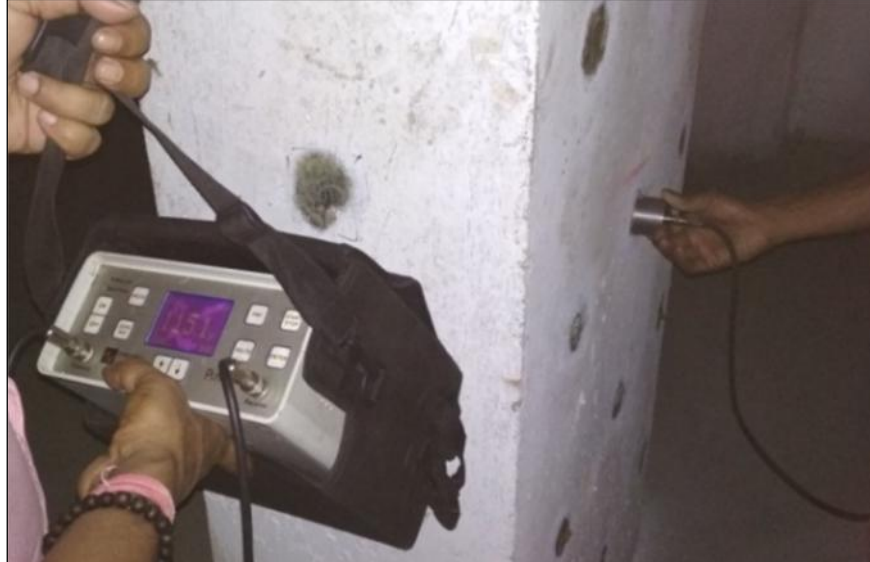
In this test procedure, the ultra-sonic pulse is produced by the transducer which is held in contact with one surface of the concrete and the pulse of vibration is converted into an electrical signal received by the receiver which is held in contact with another surface of the concrete as shown in Fig-4.3. The pulse velocity (V) is given by  $V=L/T$  where, L is the path length and T is the time taken by the pulse to travel within the concrete from the transducer to the receiver. The quality of concrete is evaluated by means of velocity obtained.

**Fig-4.3:** Ultrasonic Pulse Velocity assess the Quality of Concrete

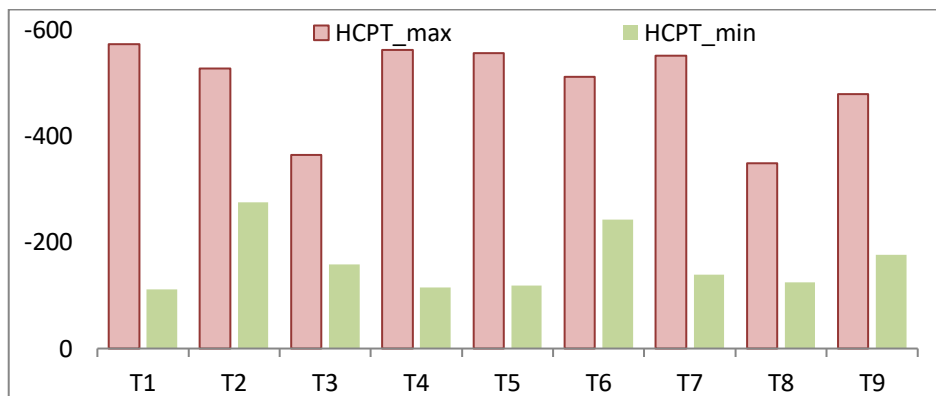
Based on the detail study of Half-Cell Potentiometer (HCP) results, it is noted that the basement columns have suffered greater susceptibility to corrosion at most of the tower buildings as shown below in Fig-5.2.

**Fig-5.2:** Corrosion Mapping of Basement Columns for different Tower Buildings

The maximum HCP value at basement ranges from -348 mV to -572 mV.

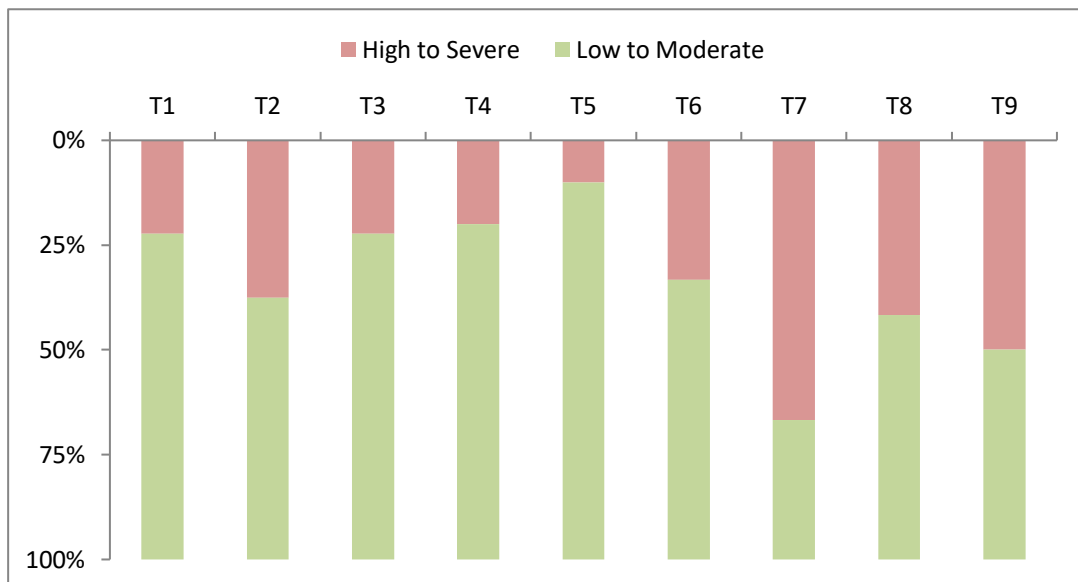
The Corrosion Mapping with respect to degree of susceptibility as obtained by Half Cell Potentiometer at Columns at various floors of all the nine towers are categorized as per ASTM criterion as shown in Fig-5.4 below.

**Fig-5.4:** Mapping of Corrosion for different Towers with respect to Degree of Corrosion

It is observed that Tower Number T2, T6, T7, T8 and T9 have suffered high to severe degree of corrosion risk for columns to the tune of 38%, 33%, 67%, 42% and 50% of the total tested floors of each tower. These five towers having greater affected zones of corrosion distress are considered for the further detail study. The overall corrosion risk is attempted to be mapped with respect to the design concrete grade of respective floors and for all buildings.

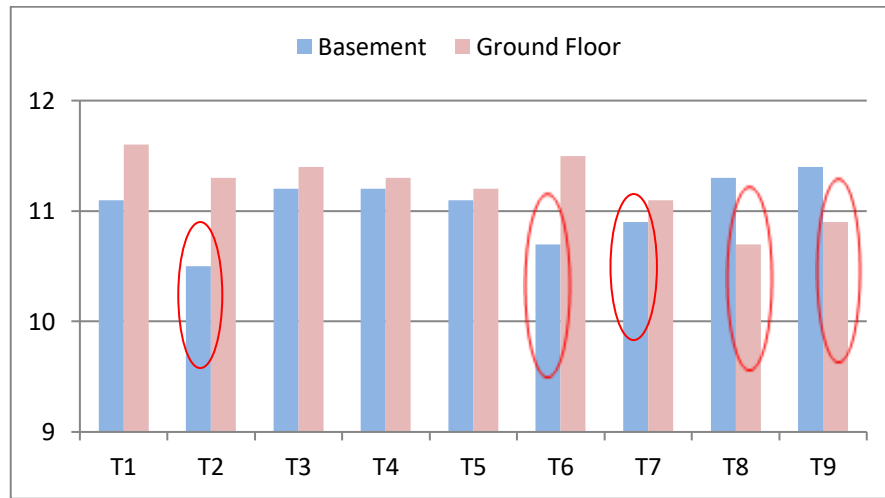
From the study of pH and chloride content of concrete, it is noted that the pH values of column concrete of basement and ground floor have reduced to a greater extent at the tower buildings namely T2, T6, T7, T8, T9 as shown below in Fig-5.5.

**Fig-5.5:** Mapping of pH value of Concrete Columns of different Towers

It shows that basement and ground floor columns have suffered greater loss of alkalinity with **pH < 11** at those towers namely T2, T6, T7, T8, T9 indicating higher susceptibility to corrosion, which are in tune with the HCPT results in general.

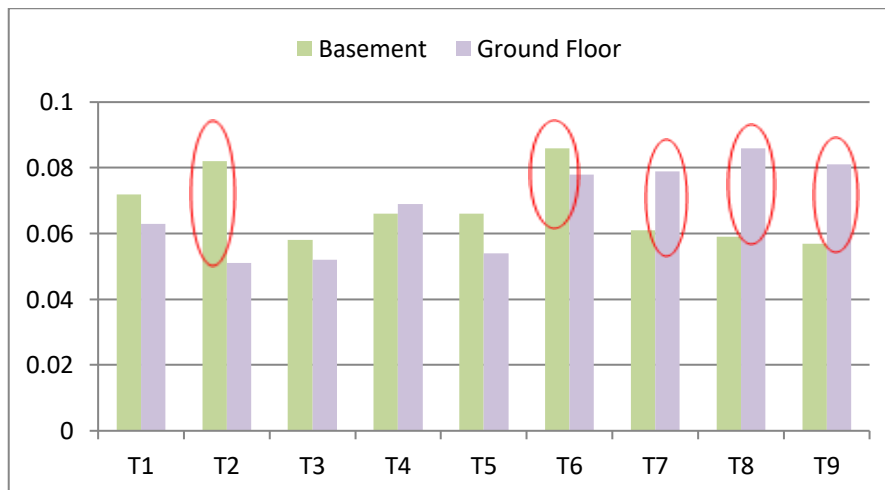
The chloride content as obtained from the chemical analysis of concrete for all the towers buildings is shown in Fig-5.6 below.

**Fig-5.6:** Mapping of Chloride Content of Concrete Columns of different Towers

Similarly, from the study of chloride content of concrete, it is noted that the columns of basement and ground floor have greater content of chloride, indicating higher susceptibility to corrosion at those tower buildings namely T2, T6, T7, T8, T9. These results are also in tune with the HCPT results in general.

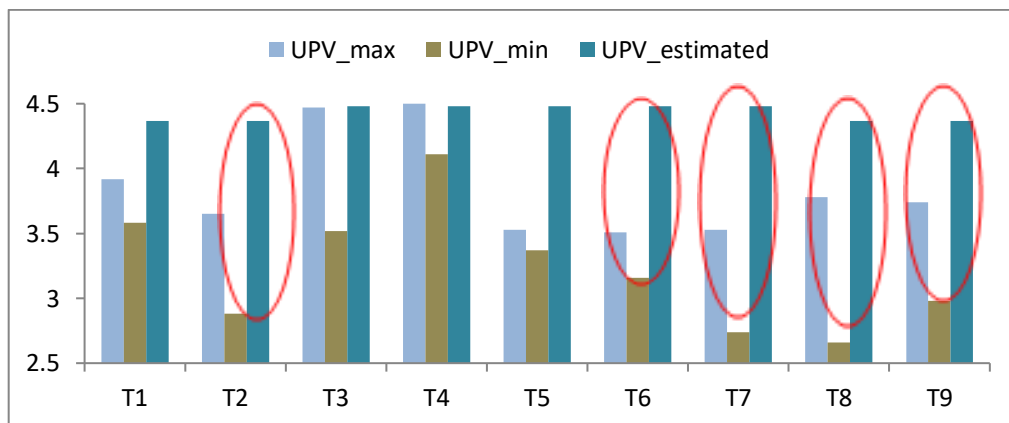
Similarly, the column of the ground floor is shown in Fig 5.8 below.

**Fig-5.8:** UPV Mapping of Ground Floor Columns for different Tower Buildings

It is further observed that the minimum Ultrasonic Pulse Velocity (UPV) is lower than the estimated value in all location which may be due to local poor quality of concrete. However, there is a significant difference between the maximum UPV and the required UPV value at Tower number T2, T6, T7, T8 and T9. It is quite evident that the Ultrasonic Pulse Velocity values are suffered due to degraded quality of concrete which

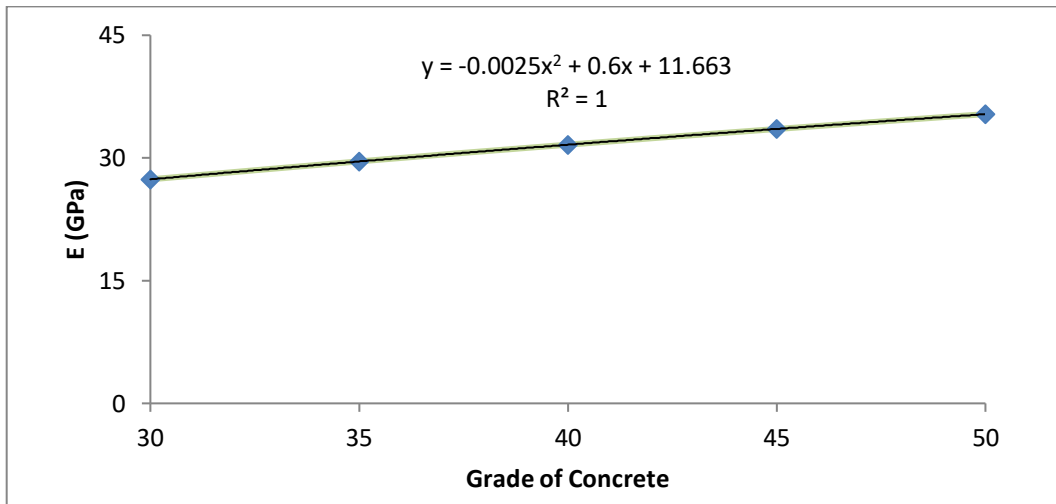
The desired elastic modulus of concrete for the different grade of concrete used in the subject buildings as per IS 456:2000 is shown in Fig-5.9 below.

**Fig-5.9:** Modulus of Elasticity (E) for Different Grade of Concrete

It is evident that the modulus of elasticity increases in a parabolic manner with the increase of concrete grade.

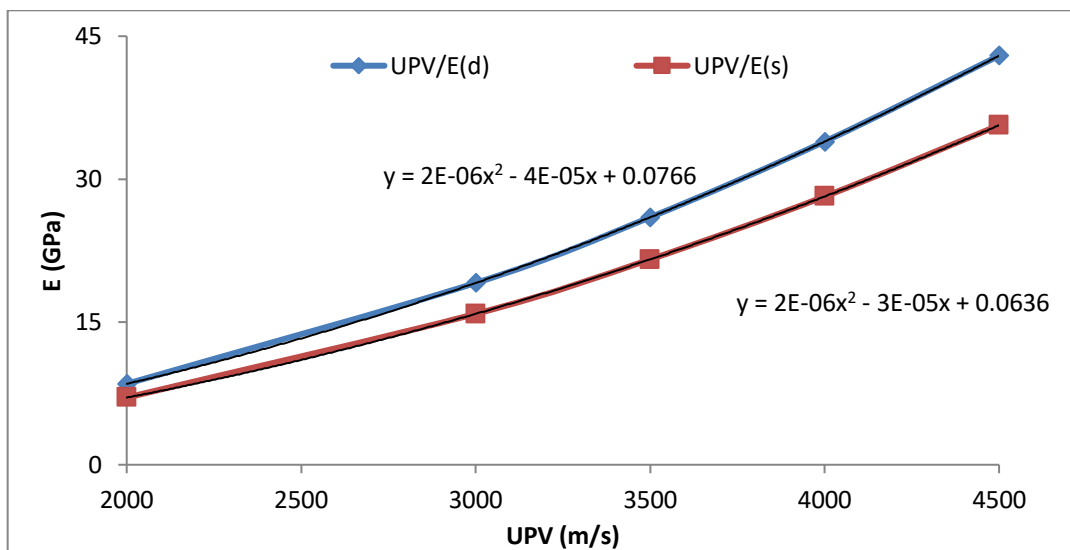
Further, the estimated dynamic and static modulus of concrete for different Ultrasonic Pulse Velocity (UPV) values as per IS 13311(Part-I):1992 and relevant research literature [Lydon et. al.] is shown in Fig-5.10 below.

**Fig-5.10:** Modulus of Elasticity (E) for various UPV values

The estimated modulus of elasticity also increases with the increase of Ultrasonic Pulse Velocity values but in a faster ascending order. Thus in case of high grade of concrete as used in the basement and the ground floor of the towers, high value of Ultrasonic Pulse Velocity is expected considering the compatible E values. It is quite evident from the above figures that the higher design grade of concrete should have high values of elastic modulus of concrete and subsequently should exhibit higher values of Ultrasonic Pulse Velocity. Any reduction from its desired value due to loss in the concrete quality in terms of cracks, voids and honeycomb will reduce its actual design strength. The basement and the ground floor columns are mostly distressed and large number of test data are obtained for further study in a detail manner.

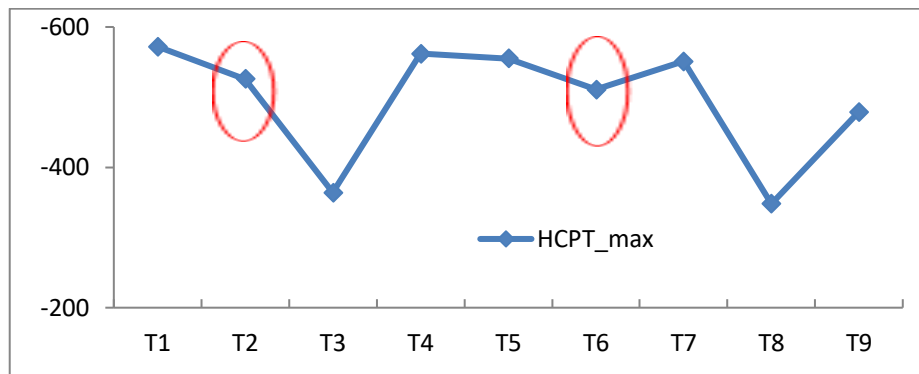
The comparison of maximum corrosion risk in terms of Half Cell Potentiometer (HCP) values of different towers for basement is shown below in Fig-5.11.

**Fig-5.11:** HCP values of Concrete Columns of Basement for different Tower Buildings

It is evident from the above figures that tower buildings T-1, T-2, T-4, T-5, T-6, T-7 & T-9 shows higher values of half-cell potentiometer readings indicating greater susceptibility to corrosion at basement. Similarly, comparison of maximum corrosion risk in terms of HCP values of different towers for ground floor is shown in Fig-5.12.

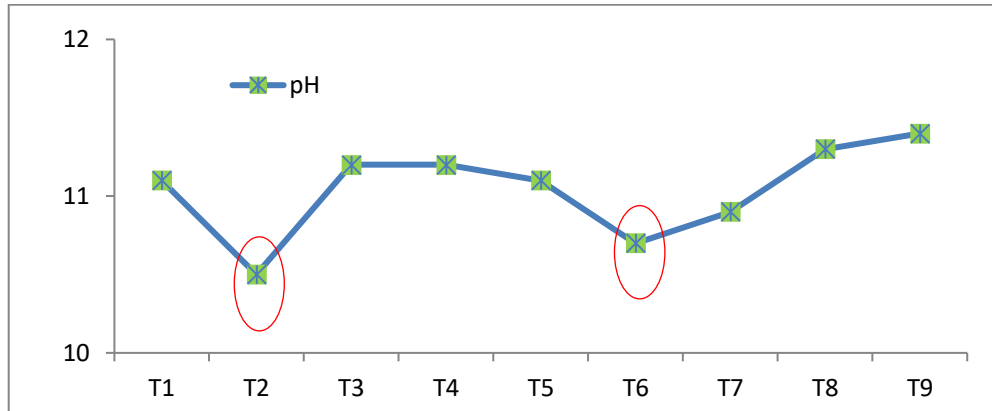
The comparison of average pH values of concrete column of different towers for basement is shown below in Fig-5.13.

**Fig-5.13:** pH values of Concrete Columns of basement for different Tower Buildings

The relatively **lower values of pH** indicate reduction of the alkalinity of concrete at those common towers of T-2 & T-6 at basement where greater susceptibility to corrosion have already observed. Similarly, comparison of average pH values of concrete column of different towers for ground floor is shown below in Fig-5.14.

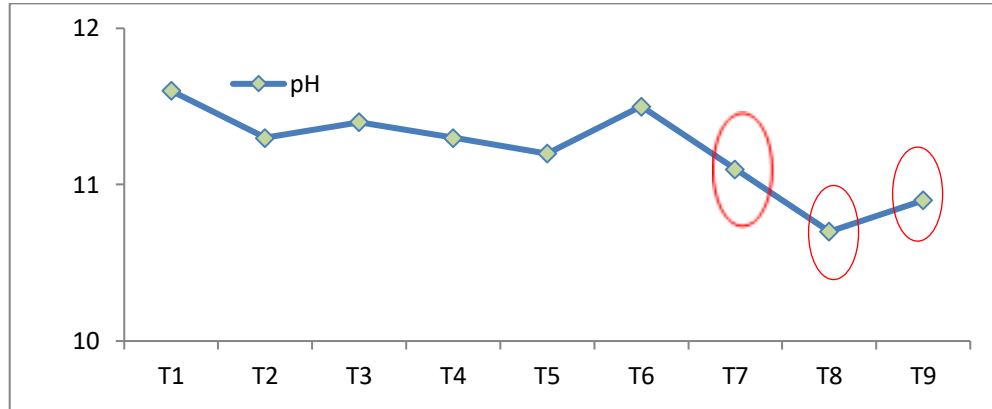
**Fig-5.14:** pH values of Ground Floor Concrete Columns for different Tower Buildings

Similarly, columns at tower buildings namely T-7, T-8 and T-9 seems to have relatively **lower values of pH** indicating reduction of the alkalinity at the ground floor concrete where greater susceptibility to corrosion already observed.

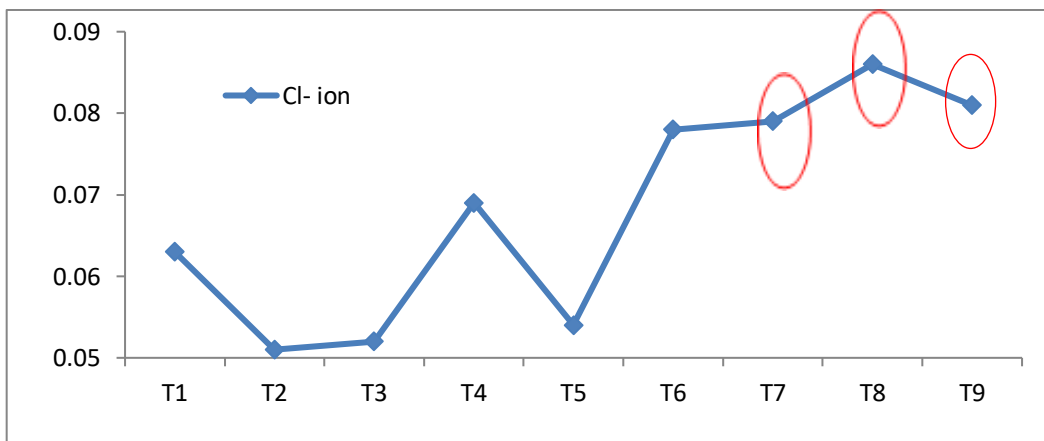
**Fig-5.16:** Chloride Content (%) for Columns of Ground Floor for different Towers

However, **higher values of chloride content** are observed at those tower buildings namely T-7, T-8 and T-9 having greater susceptibility to corrosion.

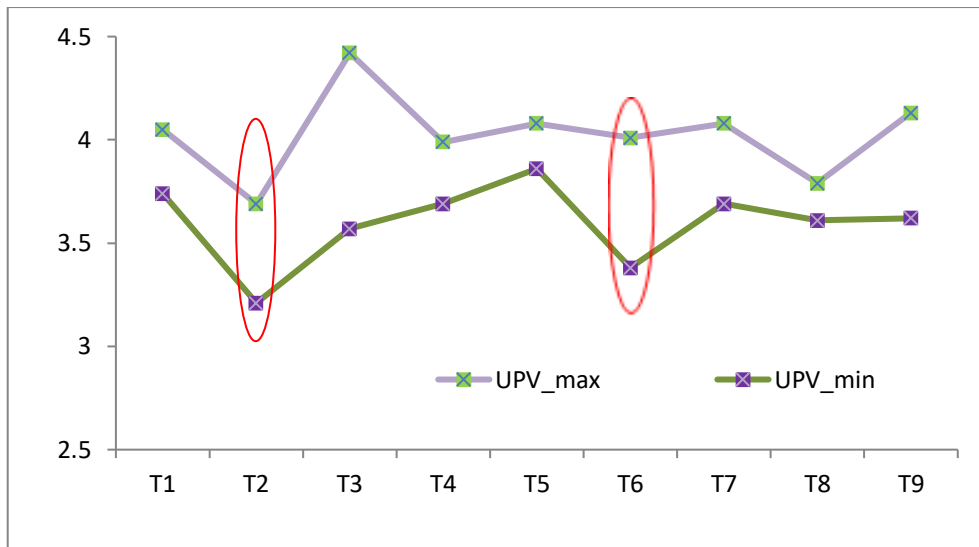
The comparison of concrete quality in terms of average Ultrasonic Pulse Velocity values of different tower buildings for basement is shown in Fig-5.17 below.

**Fig-5.17:** UPV values of Concrete Columns at Basement for different Tower Buildings

The tower buildings **T-2 & T-6** shows lower minimum values of Ultrasonic Pulse Velocity readings indicating poor quality of concrete at basement. Similarly, comparison of concrete quality in terms of average Ultrasonic Pulse Velocity values of different tower buildings for ground floor is shown below in Fig-5.18.

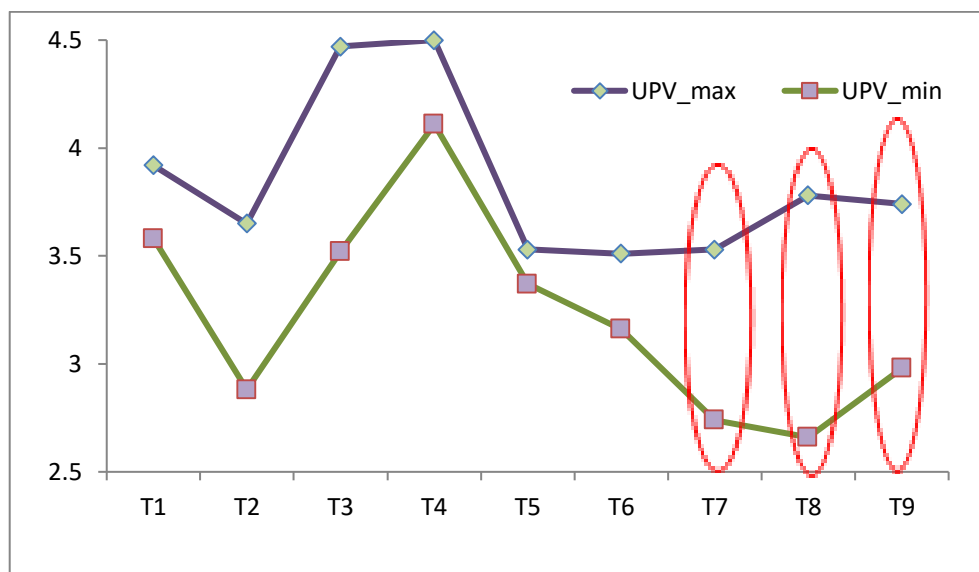
**Fig-5.18:** UPV values of Columns at Ground Floor for different Tower Buildings

Thus, tower buildings **T-2, T-7, T-8 & T-9** at ground floor exhibit poorer quality of concrete with respect to others. Based on the above study it is clearly noted that higher areas of corrosion risk exhibit possibility of lower Ultrasonic Pulse Velocity values indicating poorer quality of concrete. Thus a correlation between the higher corrosion

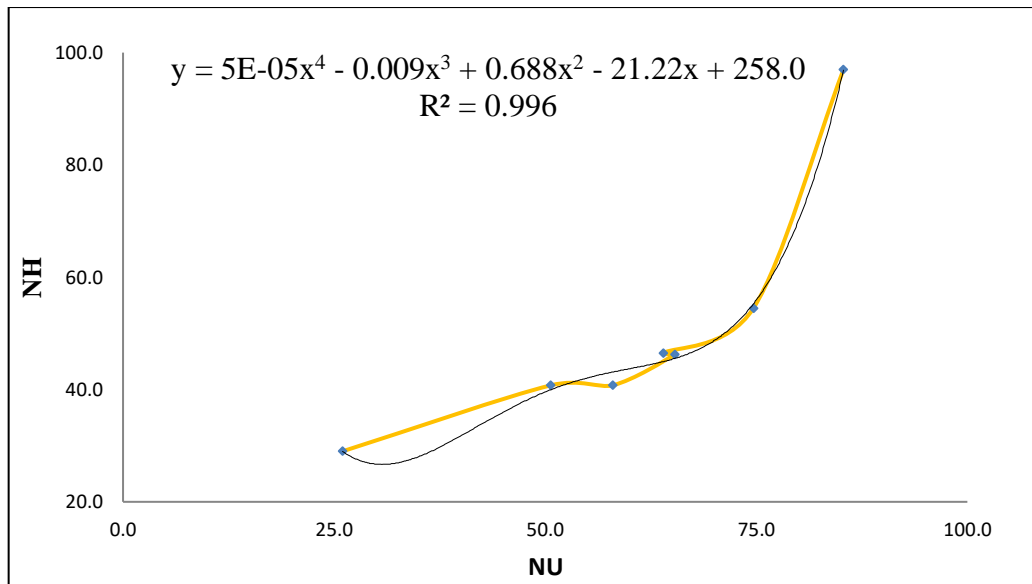
Fig-5.19 shows the correlation between these normalised UPV (NU) values with those normalised HCPT (NH) values.

**Fig-5.19:** Relation between HCPT & UPV

The above curve between NU and NH may be used to reconfirm the corrosion risk in a better way. It is also noted from the above figure that till 50% degradation in ultrasonic pulse velocity value i.e. 3.75 Km/sec, the susceptibility to corrosion is almost 40% i.e.- 350 mV, which is low to moderate as per ASTM specification. But when the degradation in UPV is about 66% i.e. less than 3.5 Km/sec for the considered design grade of concrete, the susceptibility to corrosion increases rapidly to the tune of high to severe ranges.
