**IMPACT OF BIOAEROSOL IN BUILDING MATERIALS
AND
ITS PREVENTION USING NANO SILICA COATING**

A Thesis

**Submitted for the partial fulfillment of the continuous assessment of
M.Tech in Environmental Biotechnology course
for the Session 2021-2023**

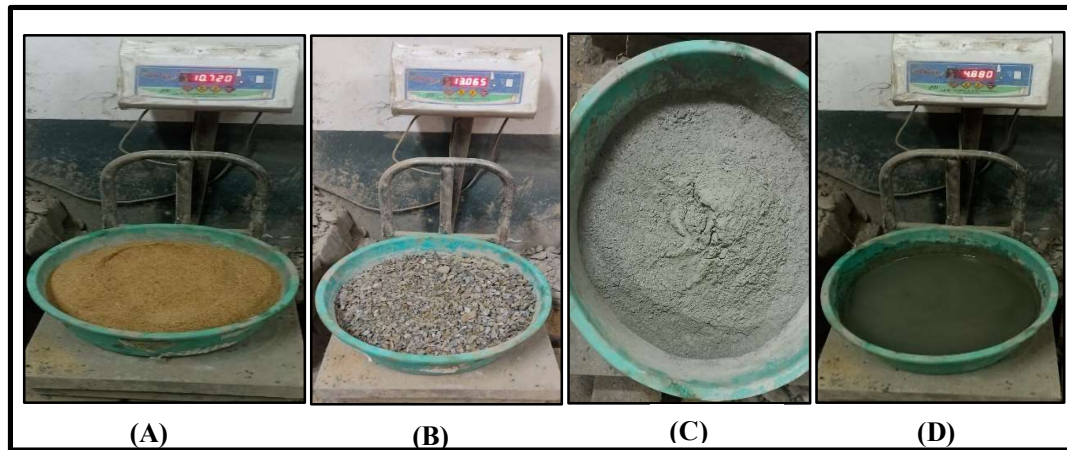
Figure 20: Casting of Plain Cement Concrete Cubes (A) Sand (B) Stone Chips (C) Cement (D) Water

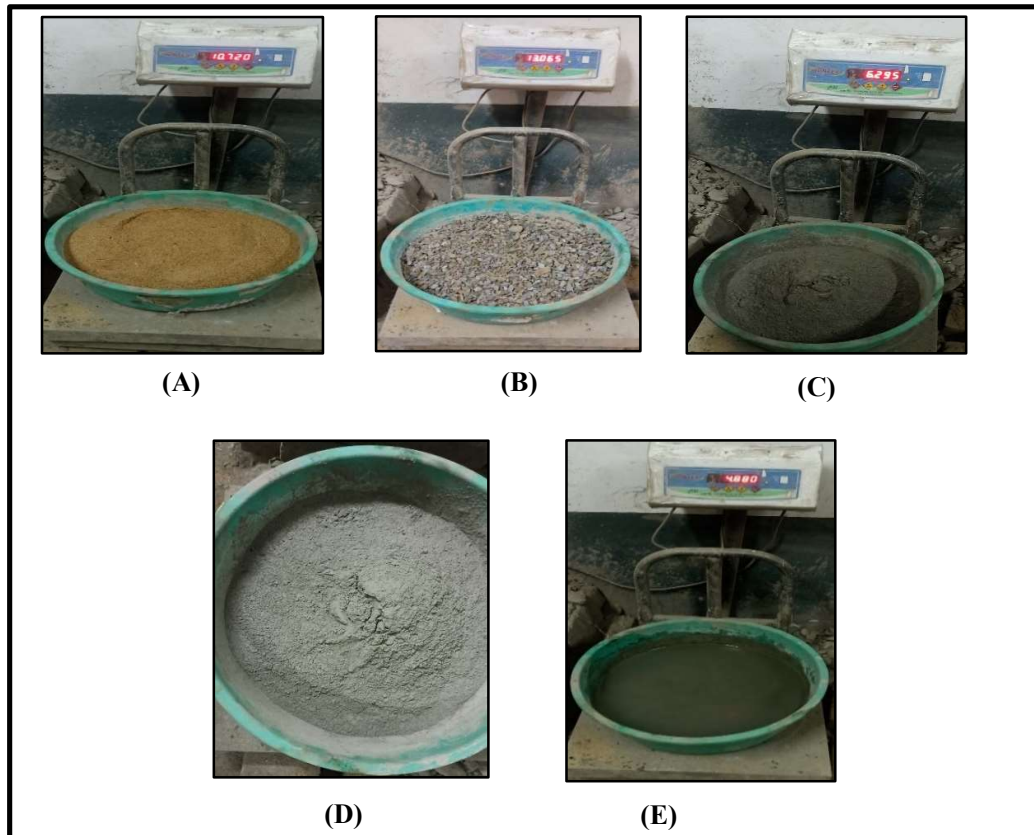
Figure 26: Casting of Fly ash Concrete Cubes (A) Sand (B) Stone Chips (C) Fly Ash (D) Cement (E) Water

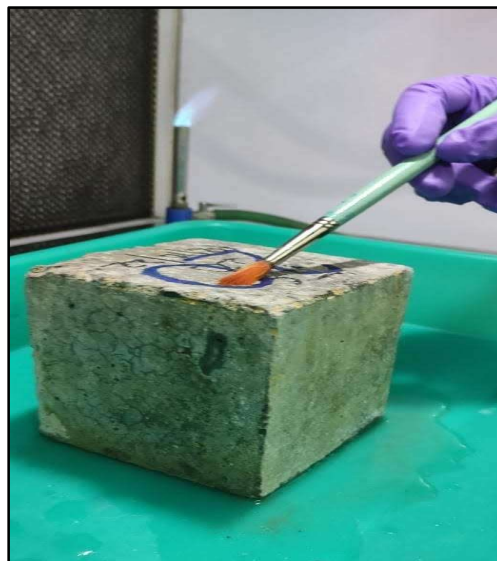
Figure 31: Applying nano silica coating in concrete surface

The fly ash concrete cubes that were selected for the study of prevention of fungal biodeterioration were brushed uniformly with the previously prepared Silicon oxide nanocoating. These cubes were then kept in the hot oven dryer at 40°C and were dried for 4 days.

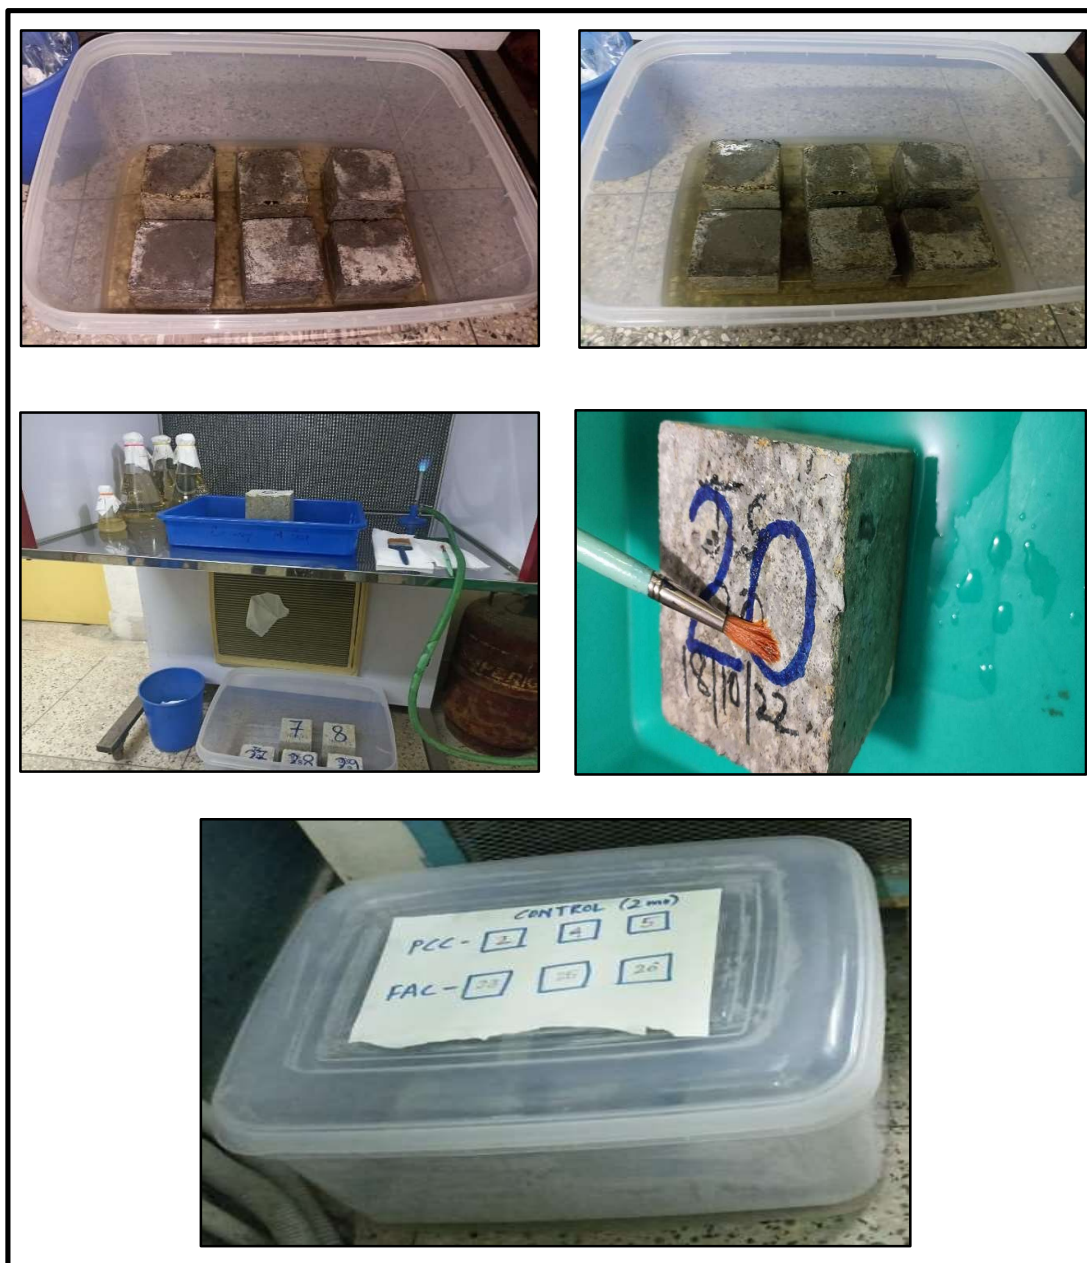
Figure 34: Experimental Setup arrangement

This experimental setup was kept at room temperature for 6 months and after every 2 months interval the cubes from each set were removed and tested to observe the changes. And respective data were recorded and analysis were done.

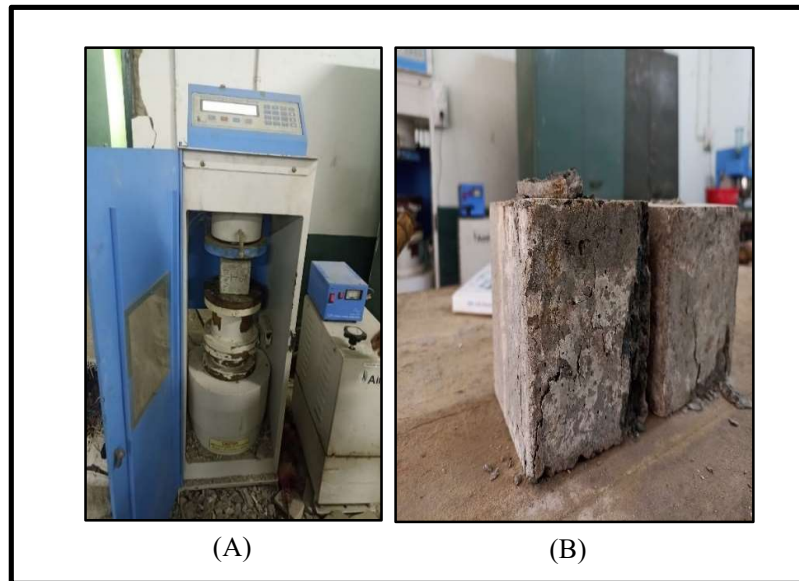
Figure 39: (A) Universal Compressive Testing Machine (B) Collapsed and broken cube

$$\text{Compressive Strength of Concrete (N/mm}^2\text{)} = \frac{\text{Maximum Load applied to the cube}}{\text{Cross-Sectional Area of the cube}}$$

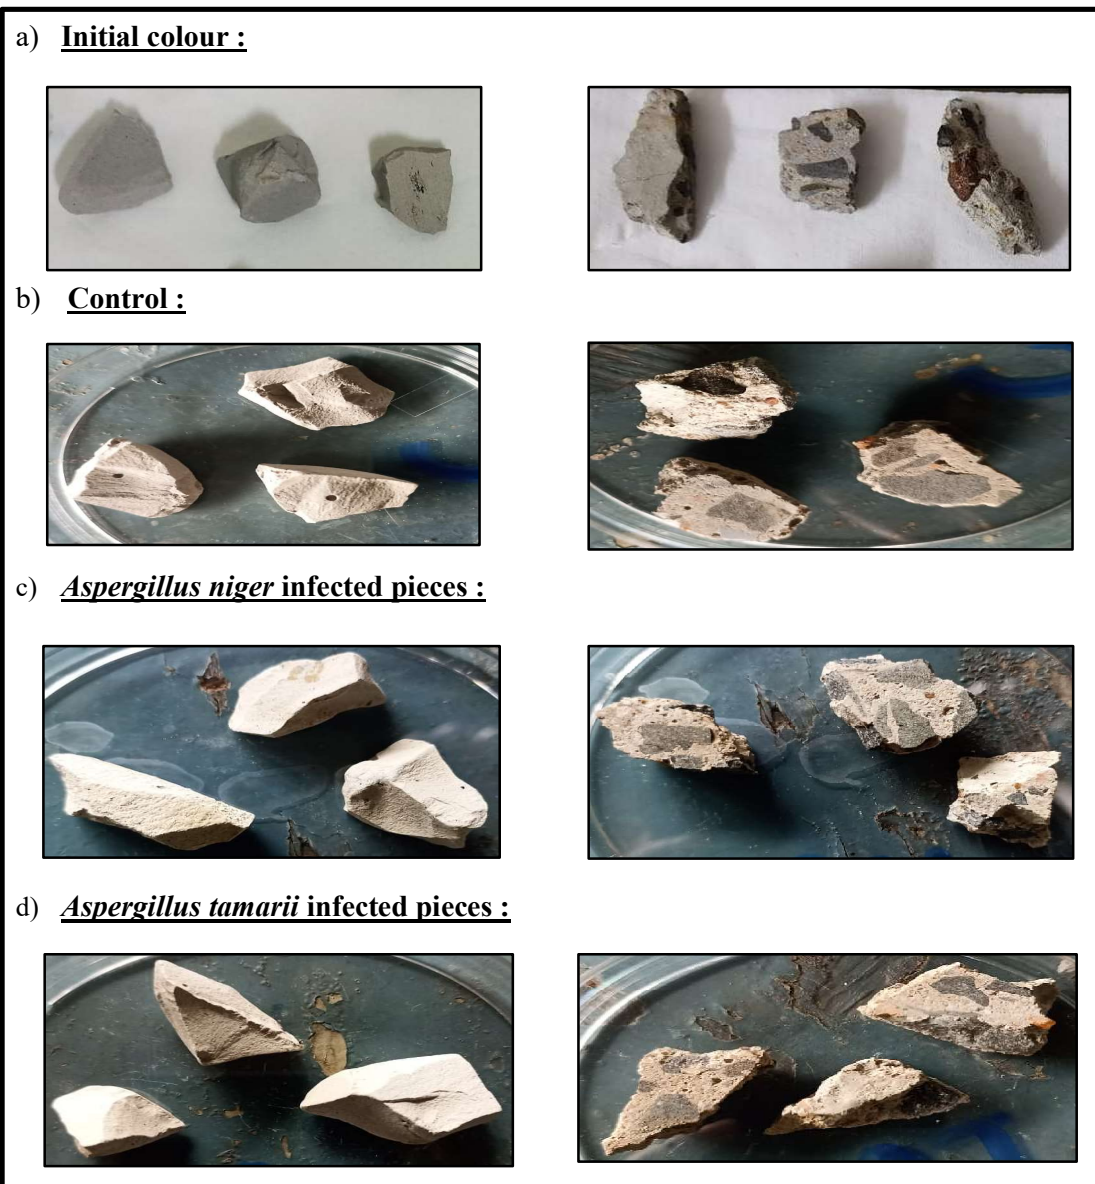
Figure 47: Observed colour changes with their colour codes (as per Geological Rock Colour Chart-Munsell, 2009)

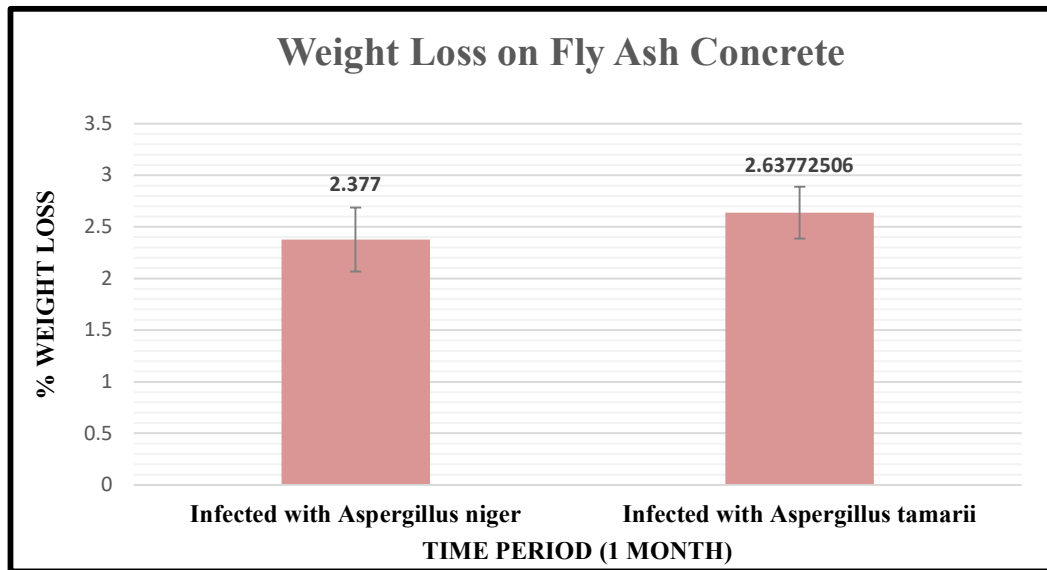
Figure 48: Comparison of Weight Loss Percentage (%) of fly ash concrete pieces between *Aspergillus niger* and *Aspergillus tamarii*

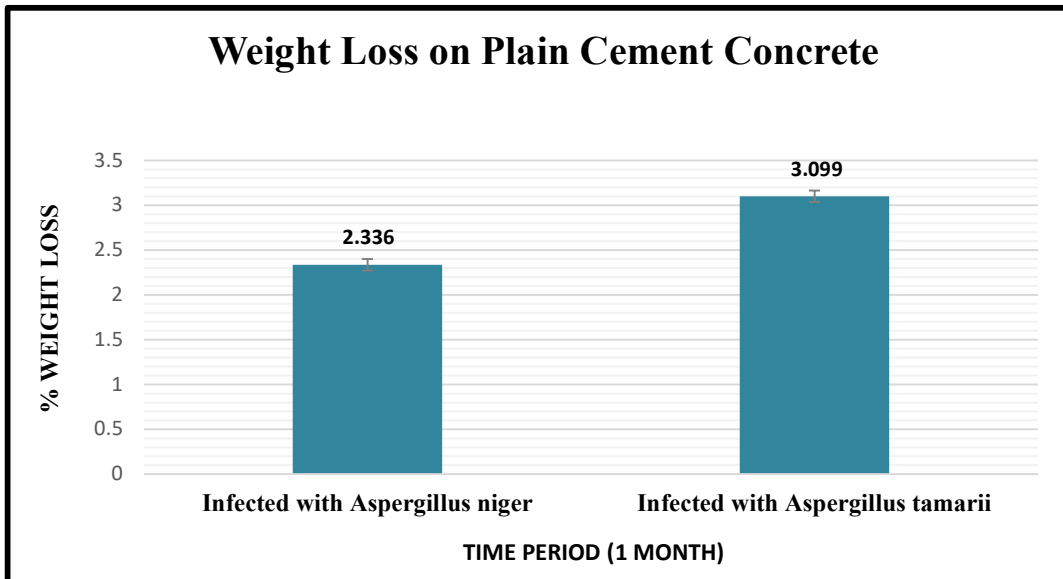
Figure 49: Comparison of Weight Loss Percentage (%) of plain cement concrete pieces between *Aspergillus niger* and *Aspergillus tamarii*

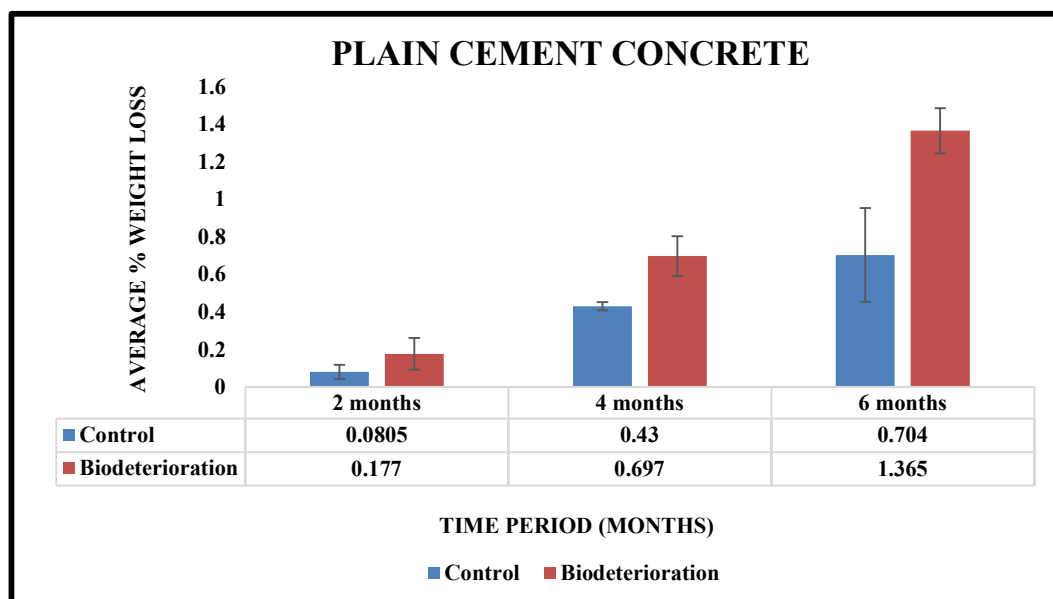
Figure 52: Comparison of percentage weight loss (%) with time (months) of concrete cubes.

Time Period	Weight (kg)		Weight Loss (kg)	Weight Loss Percentage (%)	Average Weight Loss Percentage (%)
	Initial	Final			
After 2 months	2.445	2.439	0.006	0.24539	0.177±0.085
	2.445	2.440	0.005	0.20449	
	2.44	2.438	0.002	0.08196	
After 4 months	2.44	2.420	0.020	0.81967	0.696±0.106
	2.345	2.330	0.015	0.63966	
	2.375	2.360	0.015	0.63758	
After 6 months	2.43	2.395	0.035	1.44039	1.365±0.120
	2.45	2.415	0.035	1.42857	
	2.365	2.336	0.029	1.22622

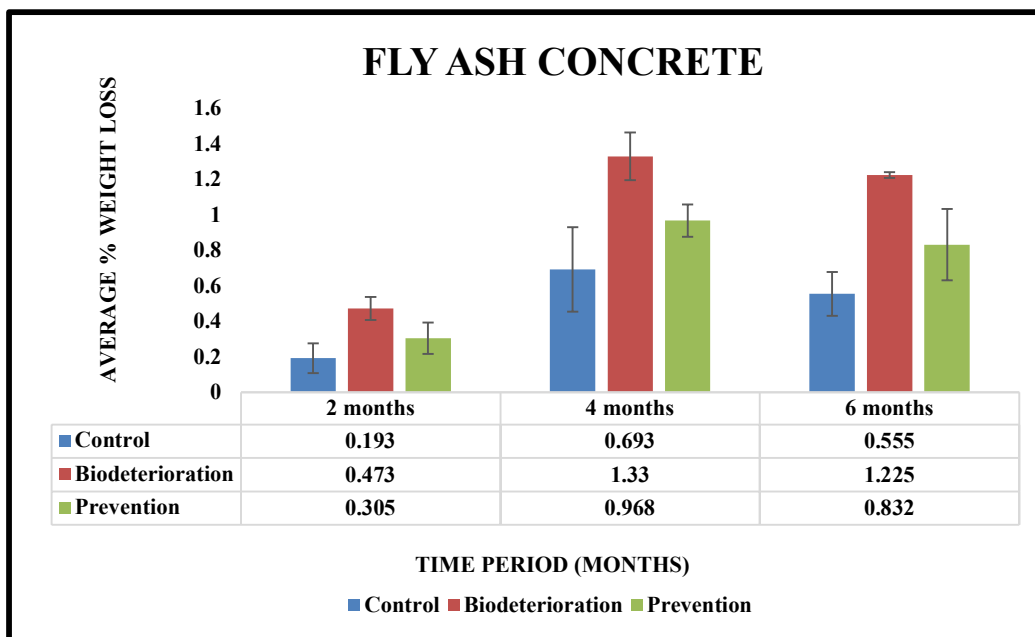
Figure 53: Comparison of percentage weight loss (%) with time (months) of concrete cubes.

Time Period	Weight (kg)		Weight Loss (kg)	Weight Loss Percentage (%)	Average Weight Loss Percentage (%)
	Initial	Final			
After 2 months	2.395	2.387	0.008	0.3340	0.304±0.089
	2.440	2.435	0.005	0.2049	
	2.395	2.386	0.009	0.3757	
After 4 months	2.465	2.440	0.025	1.0141	0.967±0.091
	2.435	2.410	0.025	1.0266	
	2.320	2.300	0.020	0.8620	
After 6 months	2.390	2.370	0.020	0.8368	0.832±0.201
	2.385	2.370	0.015	0.6289	
	2.425	2.400	0.025	1.0309

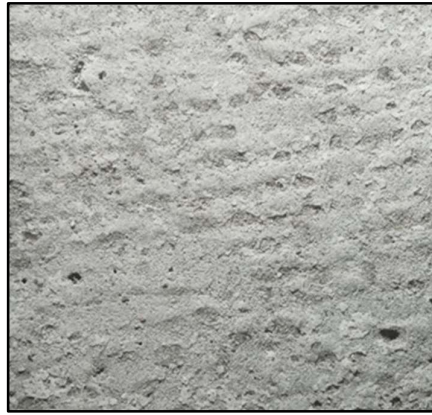
Figure 54: Stereo microscopic image of concrete cube surface from the control set-up.

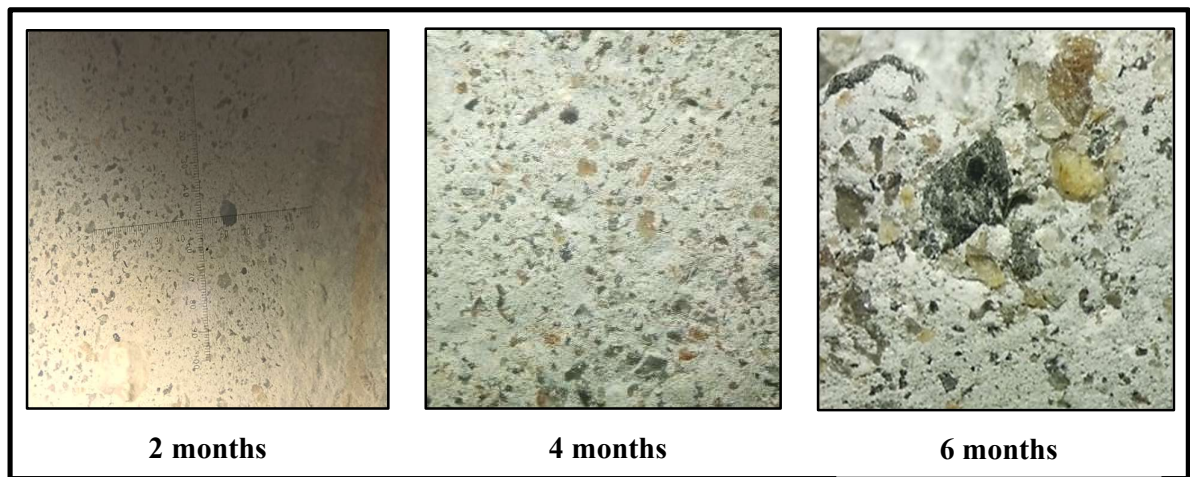
Figure 55: Stereo microscopic images of concrete cube surfaces infected by fungus from the biodeterioration set-up.

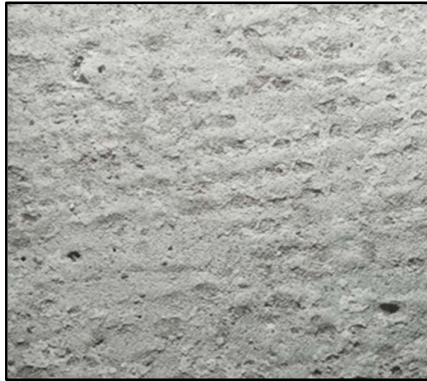
Figure 56: Stereo microscopic image of concrete cube surface from the control set-up.

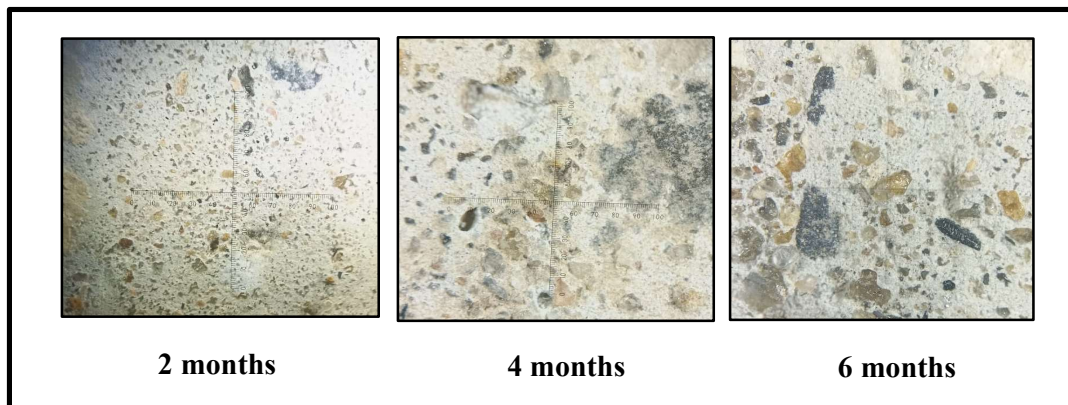
Figure 57: Stereo microscopic images of concrete cube surfaces infected by fungus from the biodeterioration set-up.

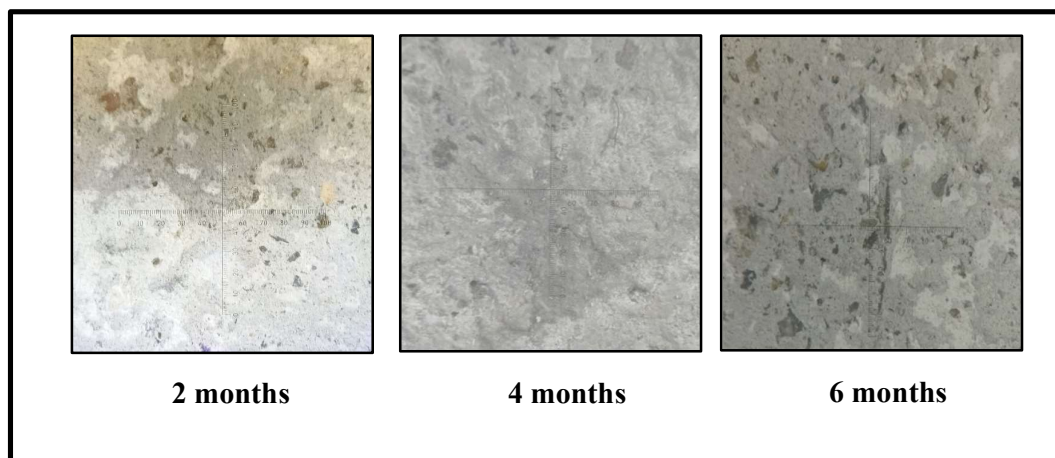
Figure 58: Stereo microscopic images of concrete cube surfaces infected by fungus from the prevention set-up.

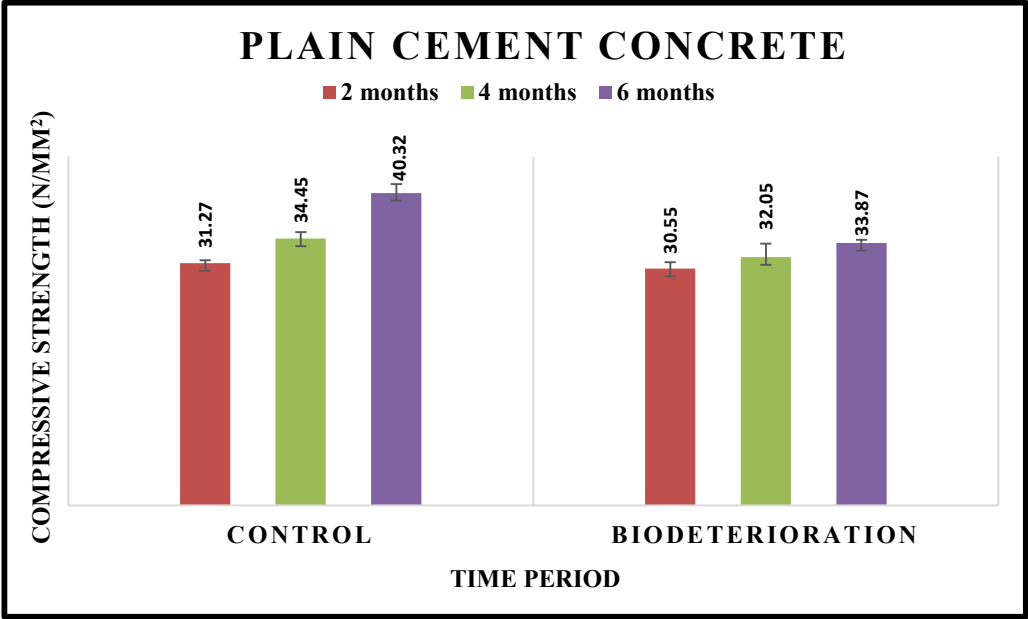
Figure 59: Comparison of compressive strength of concrete cubes with time from the respective experimental set-ups.

Time Period	Peak Load(kN)	Compressive Strength(N/mm ²)	Average Compressive Strength (N/mm ²)
After 2months	160.6 149.5 134.3	29.65 30.78 31.23	30.55±0.814
After 4months	142.6 184.4 182.9	30.6 32.59 33.98	32.05±1.7
After 6months	152.7 179.0 185.5	33.45 34.2 33.96	33.87±0.383

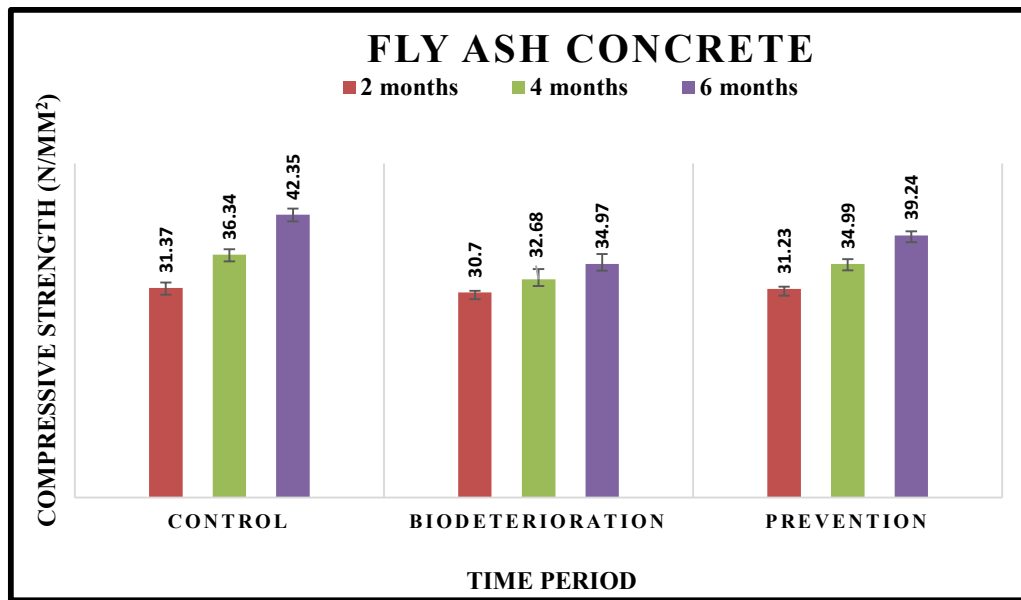
Figure 60: Comparison of compressive strength of concrete cubes with time from the respective experimental set-ups.

Time Period	Peak Load(kN)	Compressive Strength(N/mm²)	Average Compressive Strength (N/mm²)
After 2months	143.6 159.5 153.3	31.56 30.87 31.25	31.23±0.345
After 4months	174.6 185.4 178.9	33.25 34.59 34.14	34.99±0.681
After 6months	182.7 168.0 185.5	36.97 35.87 35.89	39.24±0.630

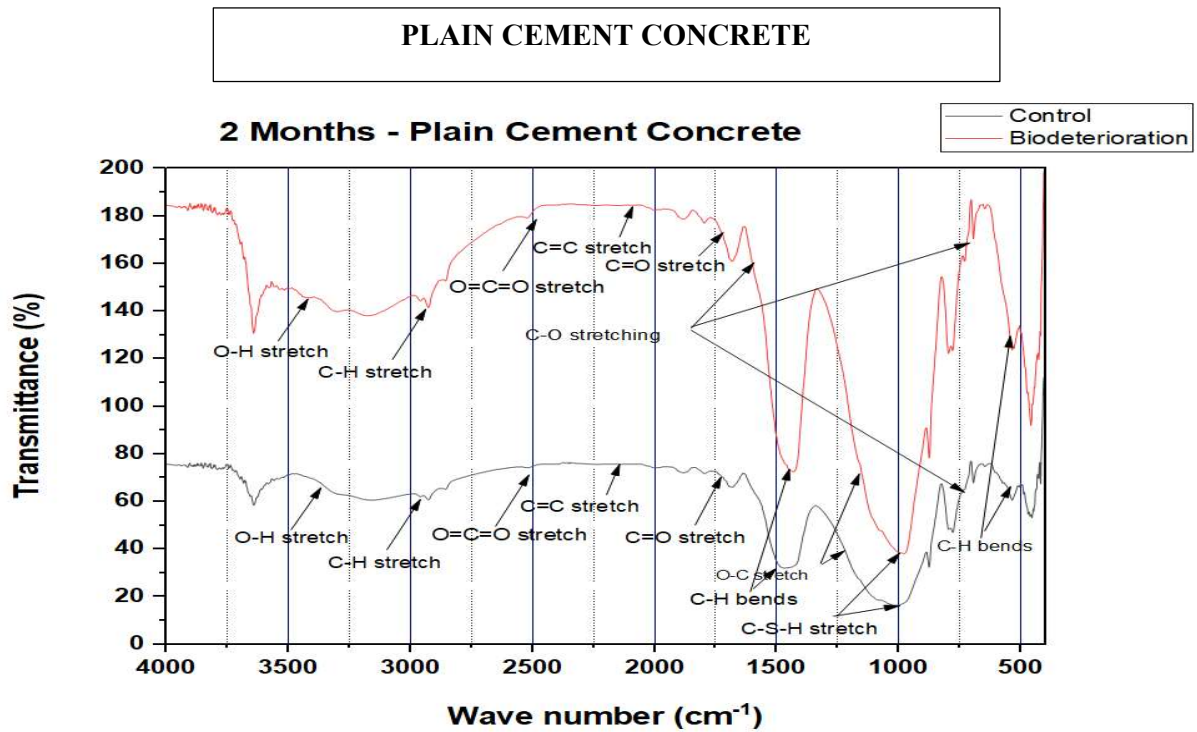
Figure 61 IR transmittance spectrum of plain cement concrete (2 months).

The FTIR spectroscopy for control concrete sample indicated the presence of portlandite [$\text{Ca}(\text{OH})_2$] at range of 3640 cm^{-1} to 3250 cm^{-1} (very weak O-H stretching vibrations) which are present in both the samples (control and biodeterioration) but for biodeterioration sample the curved got sharper with time, it means that Portlandite is mainly transformed during carbonation and leaching process. The carbonation of Portland cement is a natural process during the ageing of concrete. During the carbonation process CaCO_3 , was formed. Carbonate such as calcite (CaCO_3) from C-O stretching showed a strong symmetric absorption band (1400 and 874 cm^{-1}) which became flatten in fungi infected concrete samples with time. This band can be misleading because of absorbed water on the sample. Hydrogen bonding can change the band position and shape. Very weak stretching band (C=C) is present at range of (2000 - 1500) cm^{-1} and with time the curved peaks are getting closer for both the samples. Another asymmetric stretching band C-H was strong at initial stage which became medium and very weak in fungal infected concrete sample. A weak asymmetric stretching band from C-S-H of crystalline silica mineral quartz (Si-O) was observed at 980 cm^{-1} to 1000 cm^{-1} , which became very weak after fungal deterioration study with time. Some of other bands like C-H, C=O and O-C were also present in the control sample which became medium in fungal infected concrete sample because these bands were weakened and subsequently broken by the action of fungi with time. It depends on pH, texture, mineral constituents and relative percentage of mineral constituents of concrete. This had direct relationship with the difference in weight loss and compressive strength loss in fungal infected samples. As the bands became weak or got disappeared, the hydration products were changed which also resulted in weakening of the matrix and thereby cracks were formed. Water and other salts percolation through these cracks initiated corrosion. Therefore, the weight and compressive strength were decreased.

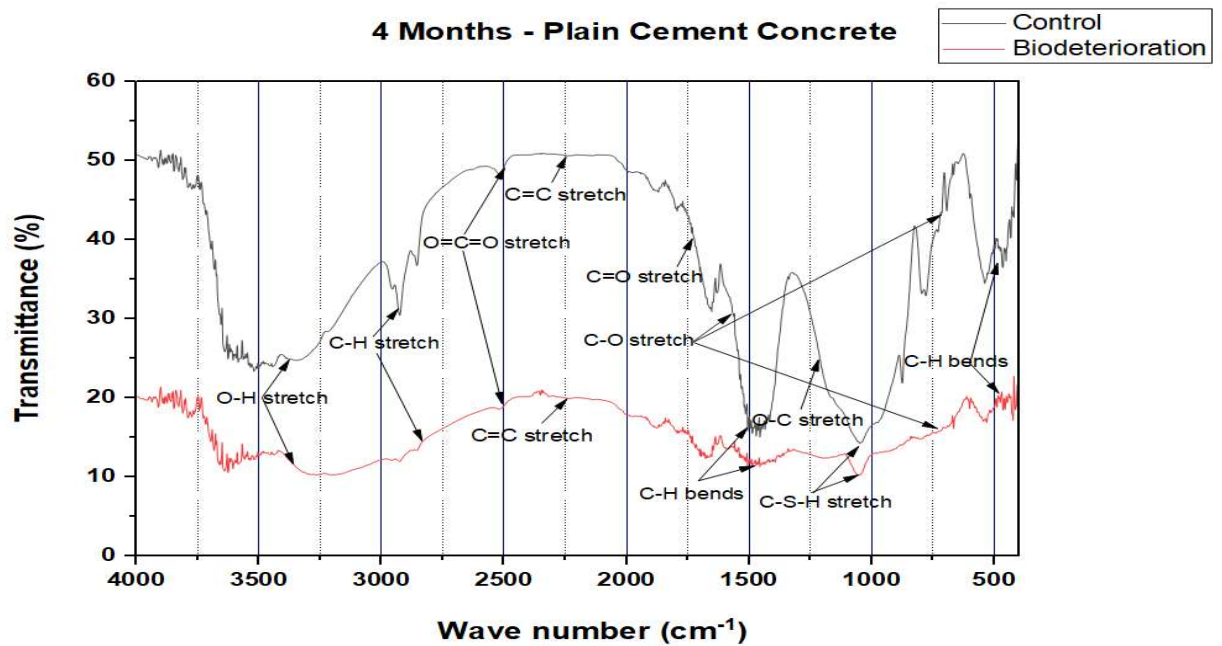
Figure 62: IR transmittance spectrum of plain cement concrete (4 months).

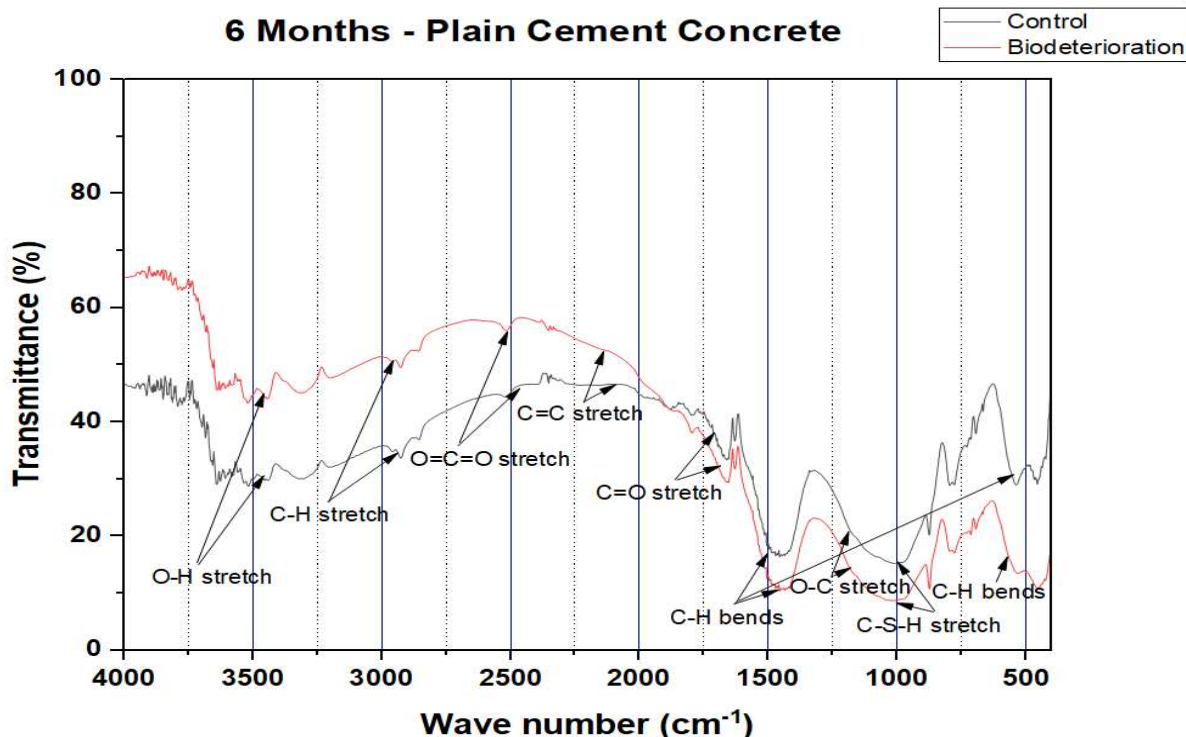
Figure 63: IR transmittance spectrum of plain cement concrete (6 months).

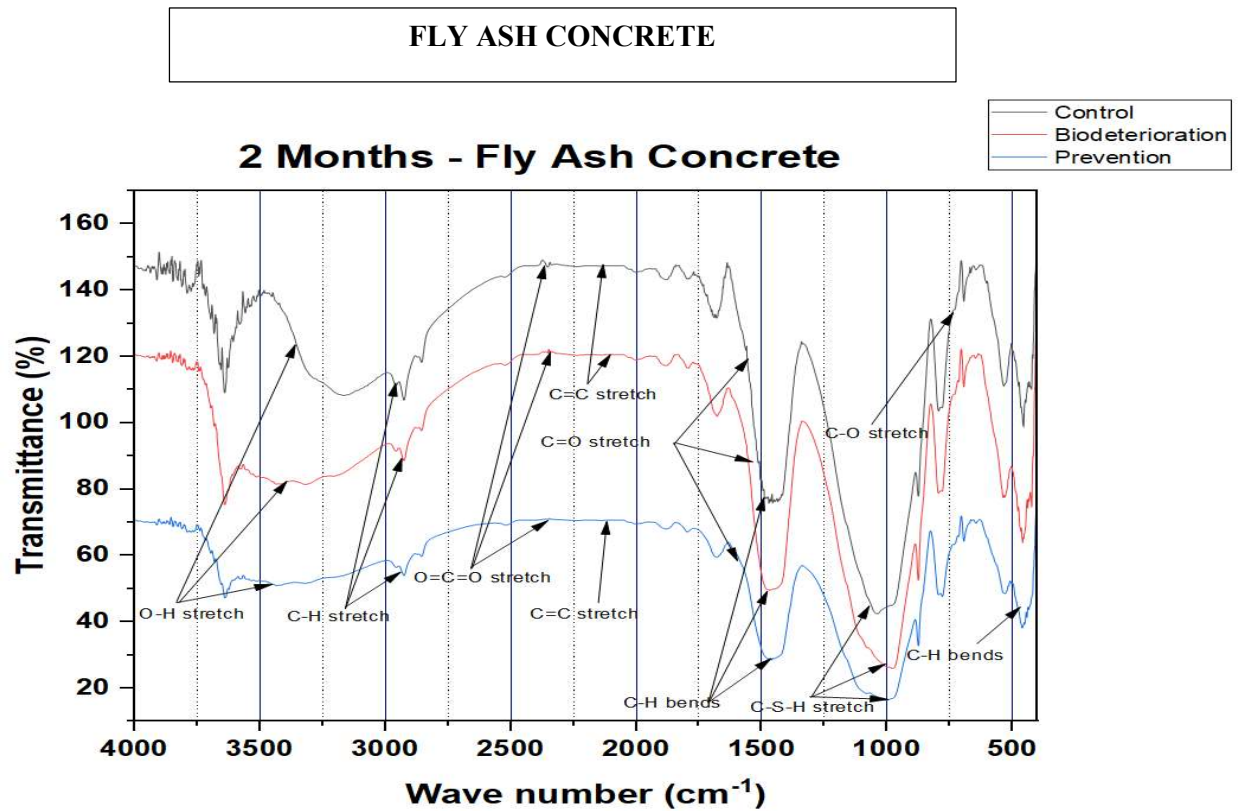
Figure 65: IR transmittance spectrum of fly ash concrete (2 months).

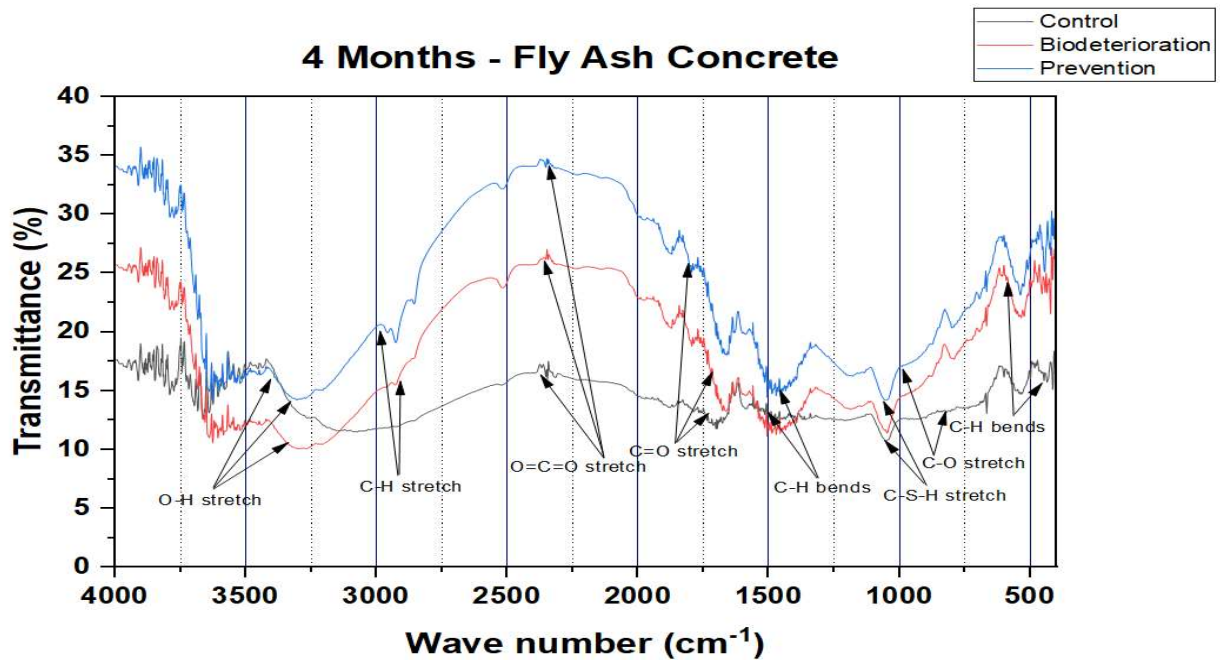
Figure 64: IR transmittance spectrum of fly ash concrete (4 months).

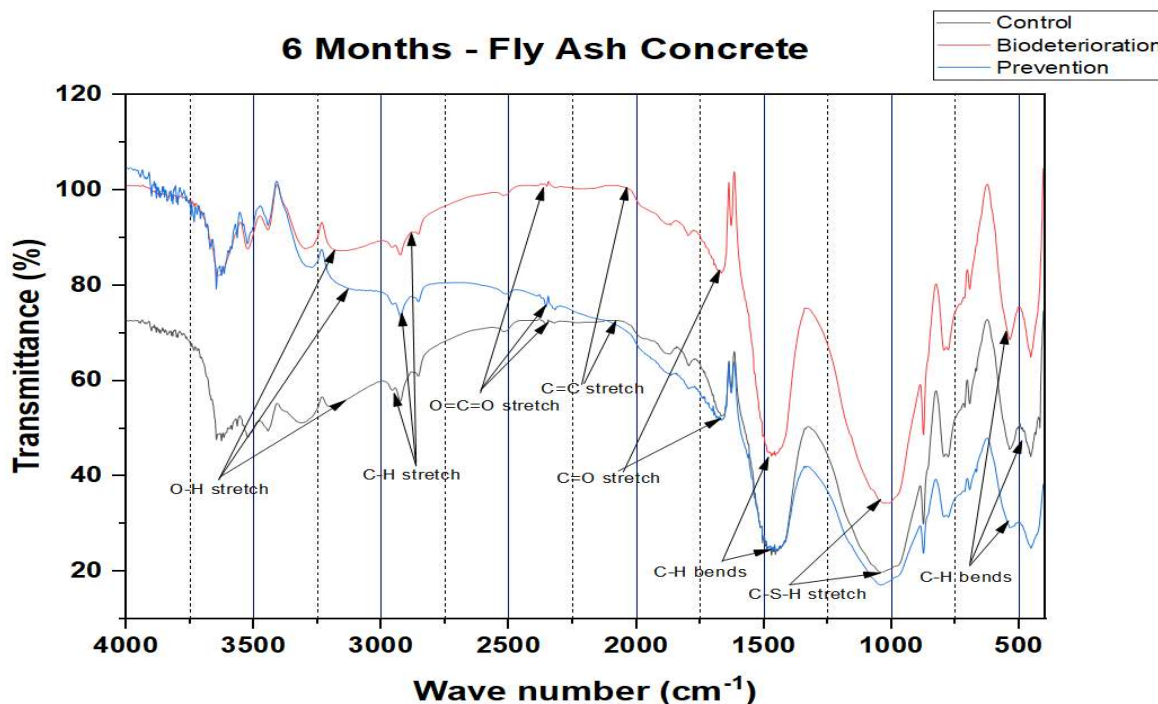
Figure 66: IR transmittance spectrum of fly ash concrete (6 months).

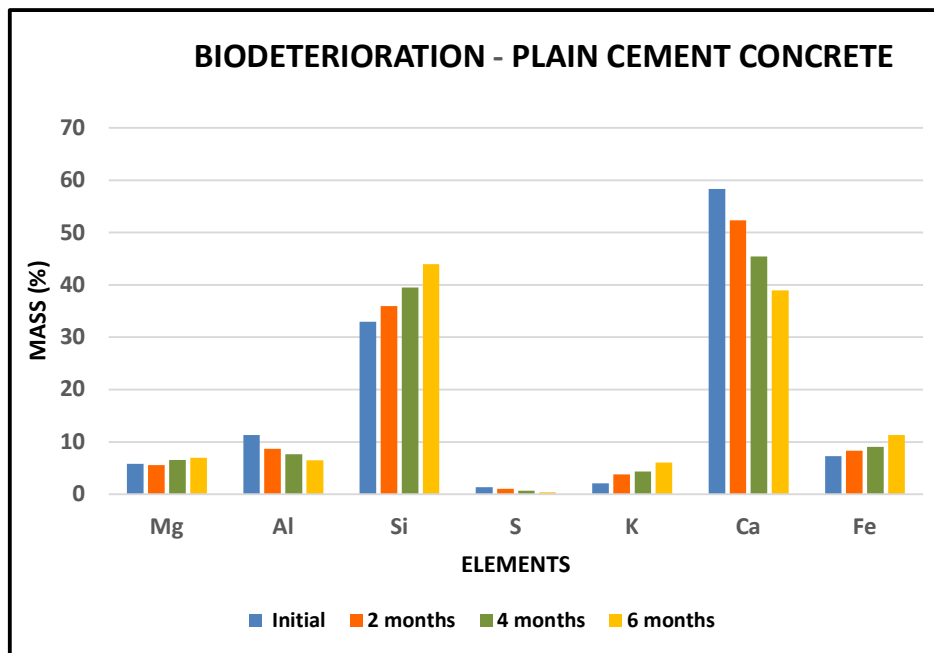
Figure 67: Mass percentage of different elemental contents of biodeteriorated plain cement concrete cubes.

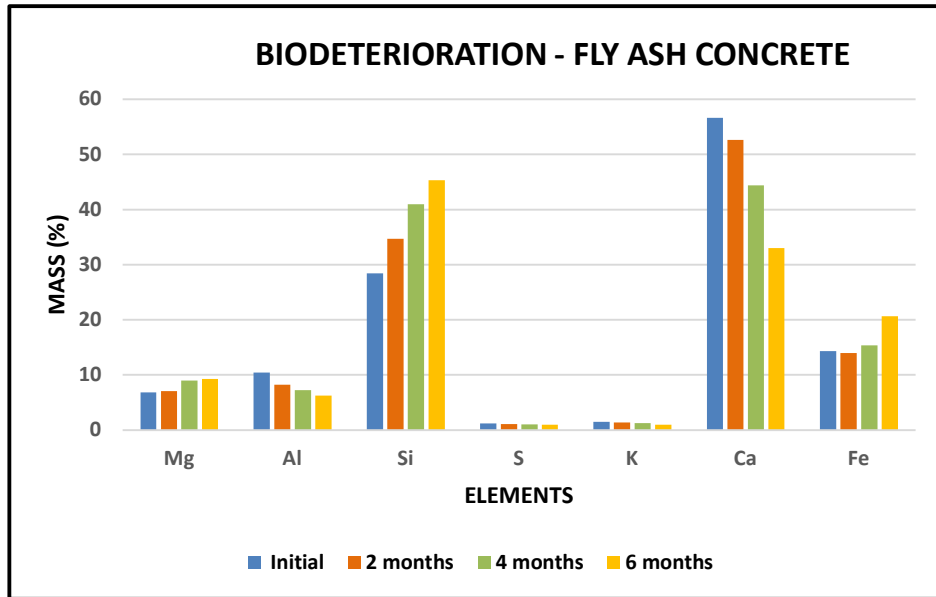
Figure 68: Mass percentage of different elemental contents of biodeteriorated fly ash concrete cubes.

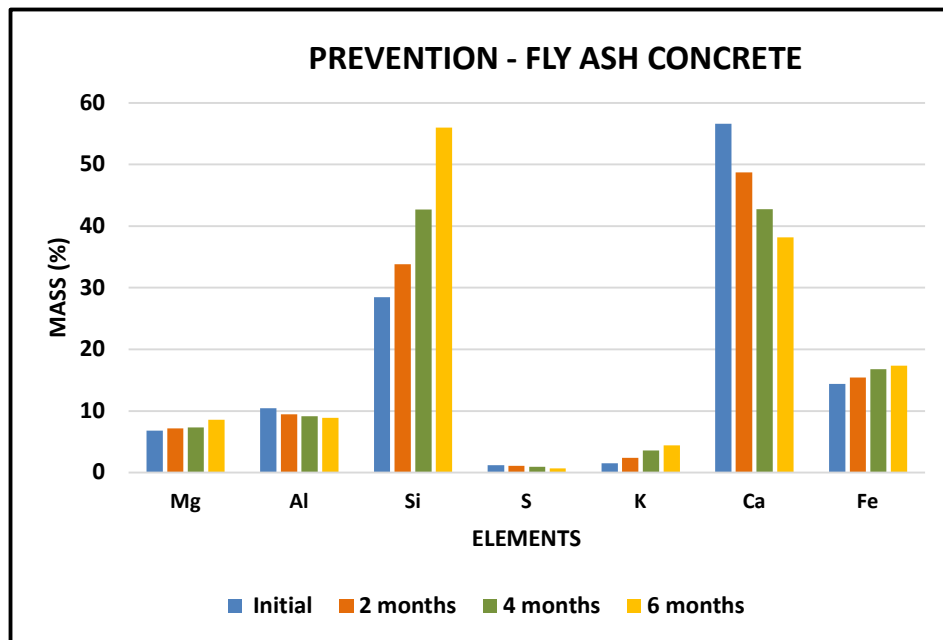
Figure 69: Mass percentage of different elemental contents of prevention set of fly ash concrete cubes.
