NATURE BASED SOLUTION FOR THE EARTHEN EMBANKMENT OF INDIAN SUNDARBAN

**MASTER OF TECHNOLOGY IN
ENVIRONMENTAL BIOTECHNOLOGY**

JADAVPUR UNIVERSITY

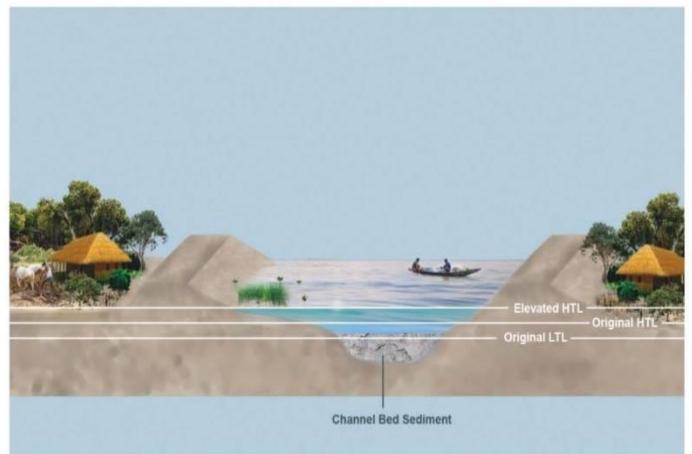
The sedimentation on embanked river bed and elevated high tide level.

Figure 2 : Sedimentation on River Bed

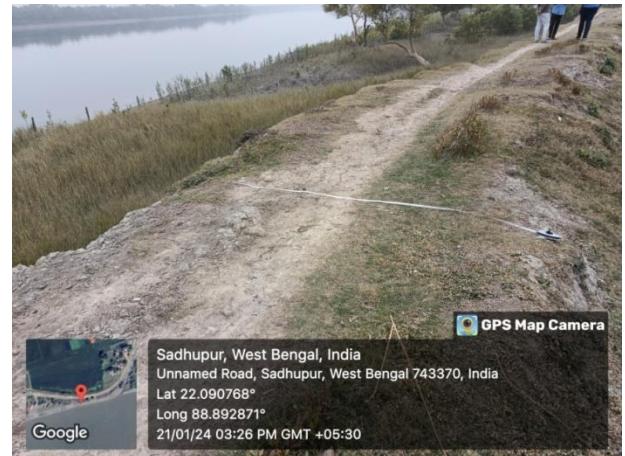
Figure 11 : Schematic diagram & Image of Embankment 1

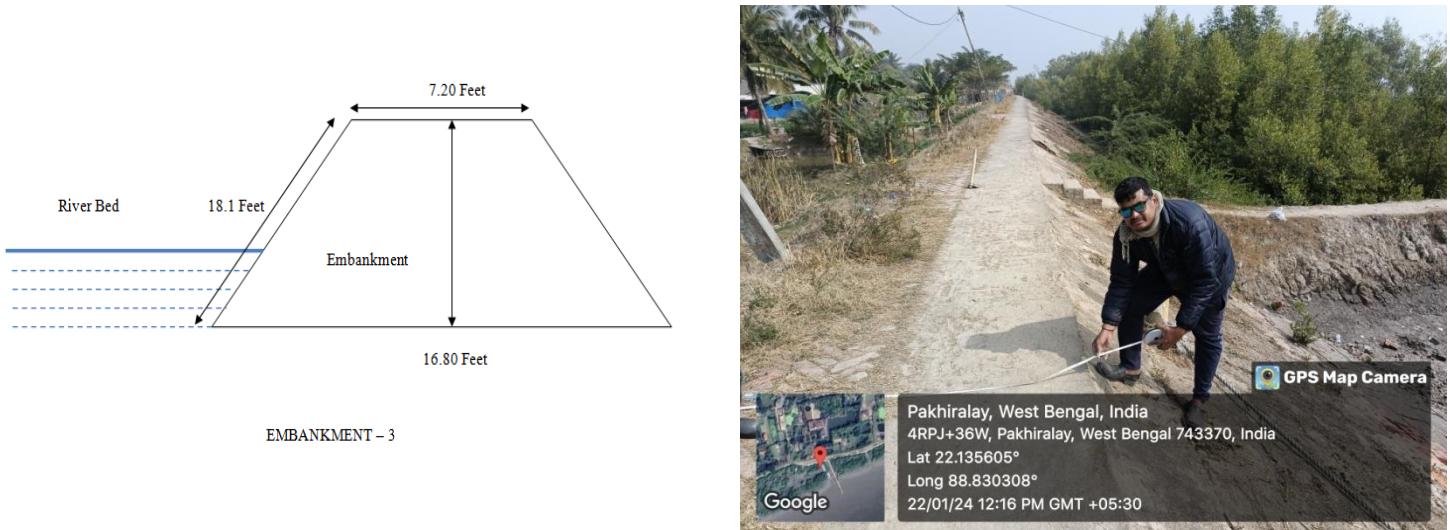
Figure 13 : Schematic diagram & Image of Embankment 3

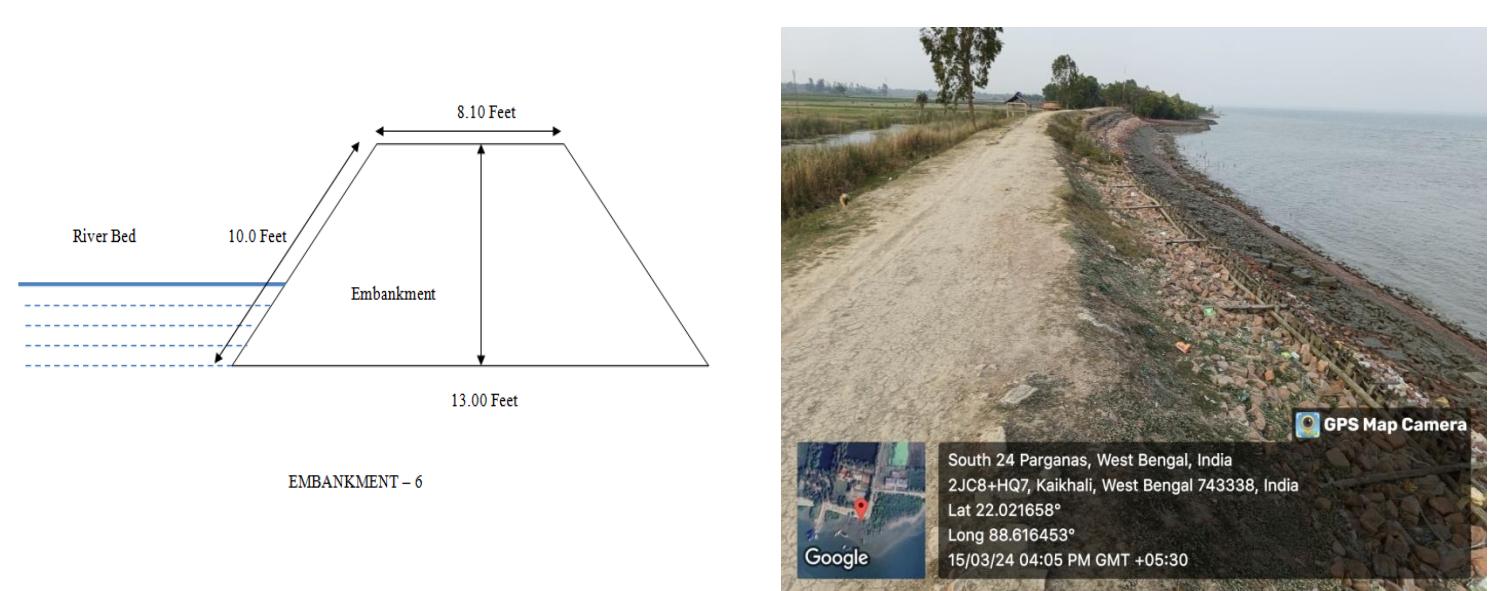
Figure 16 : Schematic diagram & Image of Embankment 6

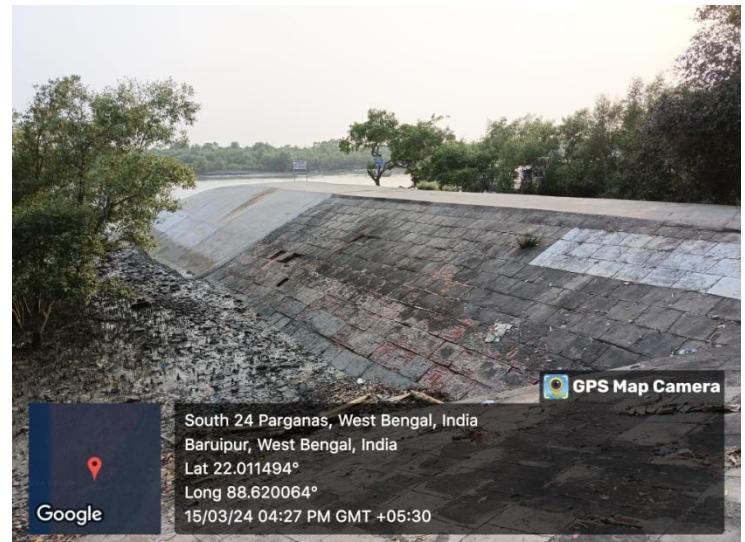
Figure 17 : Schematic diagram & Image of Embankment 7

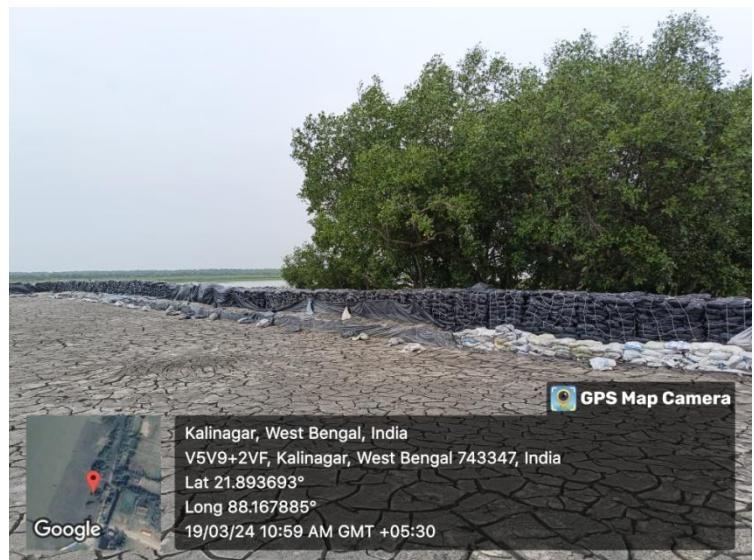
Figure 22 : Schematic diagram & Image of Embankment 12

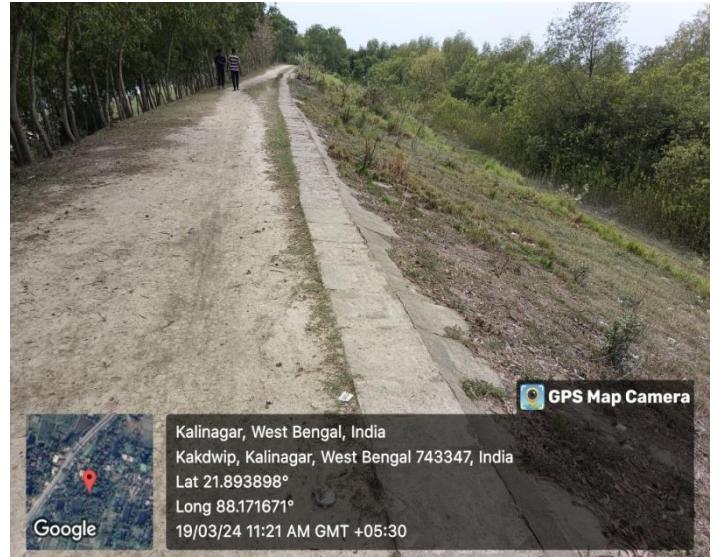
14	Earthen Embankment protected by Block pitching of Brick & Concreting	Sagar Island	11.3	14.3	48
15	Earthen Embankment protected by GeoSynthetics	Sagar Island	10.7	13.9	46.4

Figure 24 : Schematic diagram & Image of Embankment 14

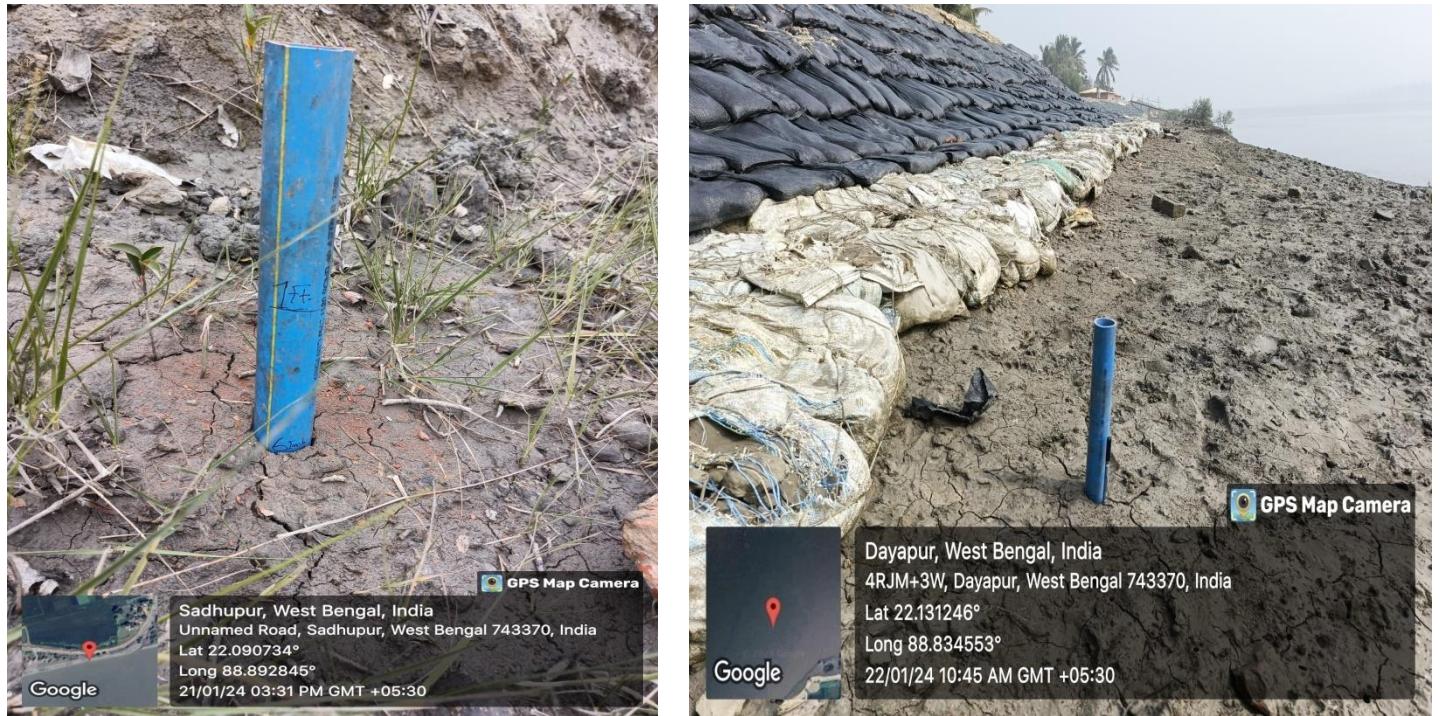
Soil samples were collected using the core cutting method, a precise and reliable approach for obtaining undisturbed soil samples. This method involves driving a PVC pipe vertically into the embankment soil to extract a core sample. The PVC pipe, typically with a diameter of 50 mm and a length of 30 cm, was used to ensure that a sufficient volume of soil was collected while maintaining the integrity of the sample. The pipe was carefully driven into the soil using a mallet, ensuring that the sample remained undisturbed and representative of the insitu conditions. Once the pipe reached the desired depth, it was carefully removed, and the soil core was extracted, capped, and sealed to prevent moisture loss. The collected samples were then labeled with sitespecific details, including location, depth, and embankment type, ensuring accurate data collection for subsequent analysis. This method was chosen for its ability to preserve the soil structure, which is crucial for accurate testing of parameters such as shear strength, moisture content, and grain size distribution. The core cutting method is particularly suited for the diverse embankment types found in the Sundarbans, as it allows for the consistent collection of samples across different materials and conditions.

Figure 26: Soil Sample Collection

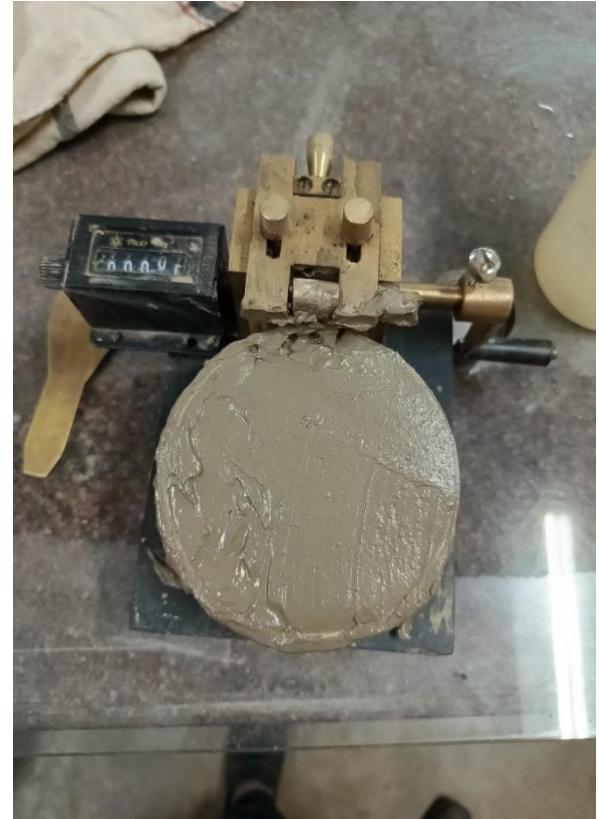
This paste is then placed in the brass cup of the apparatus. A groove is created in the soil paste using the grooving tool. The cup is then lifted and dropped repeatedly at a rate of two drops per second. The number of blows required for the groove to close over a length of 10mm is recorded. The moisture content at which the groove closes after 25 drops is considered the liquid limit of the soil. If the groove closes in more or fewer blows, a series of tests is performed, and a graph of the number of blows versus moisture content is plotted to determine the liquid limit (IS 2720 (Part 5): 1985).

Figure 32: Casagrande Apparatus

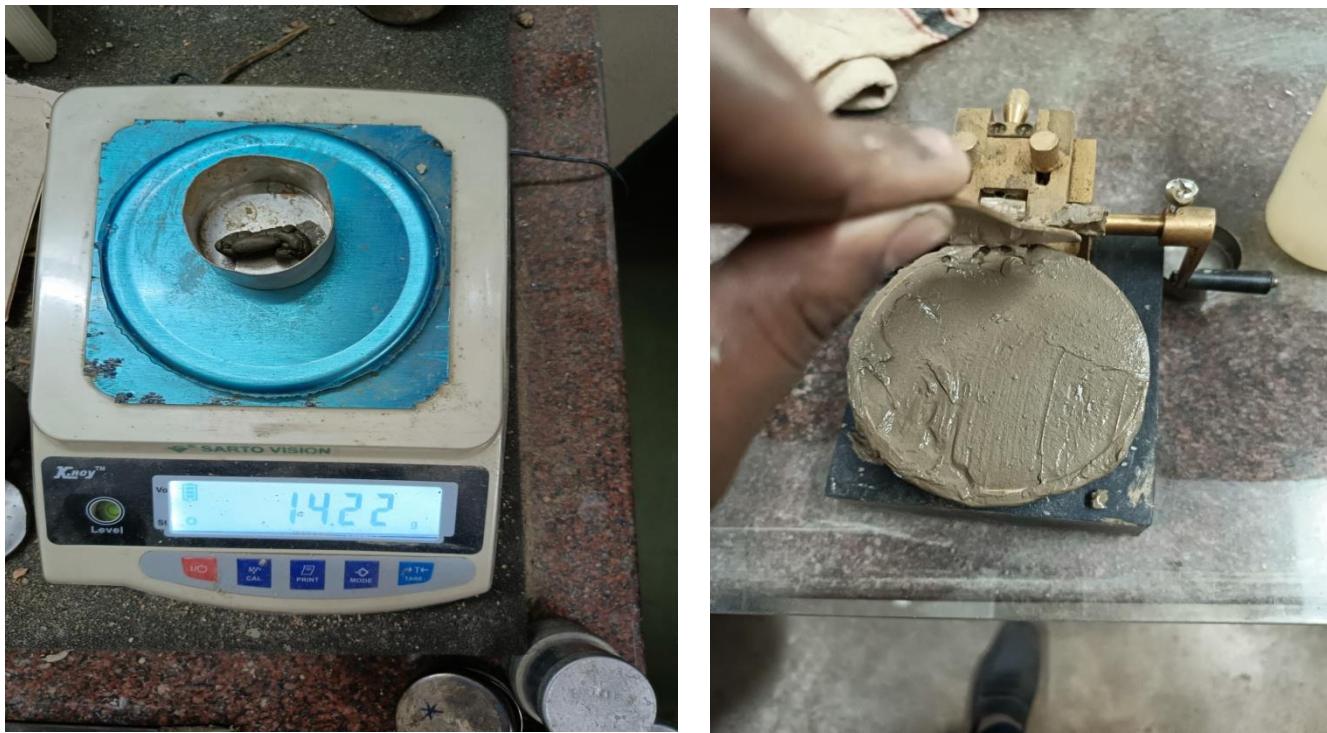
Test Procedure : A small portion of the soil sample is mixed with water until it becomes pliable enough to be rolled. The soil is then rolled out on a glass plate into a thread approximately 3mm in diameter. If the thread crumbles before reaching 3mm in diameter, the soil is too dry, and more water is added. If the thread can be rolled to less than 3mm without crumbling, it is too wet, and the test is repeated after slight drying. The plastic limit is determined as the moisture content at which the soil thread crumbles when rolled to 3mm diameter (IS 2720 (Part 5): 1985).

Figure 33 : Plastic Limit Test Using Casagrande Apparatus

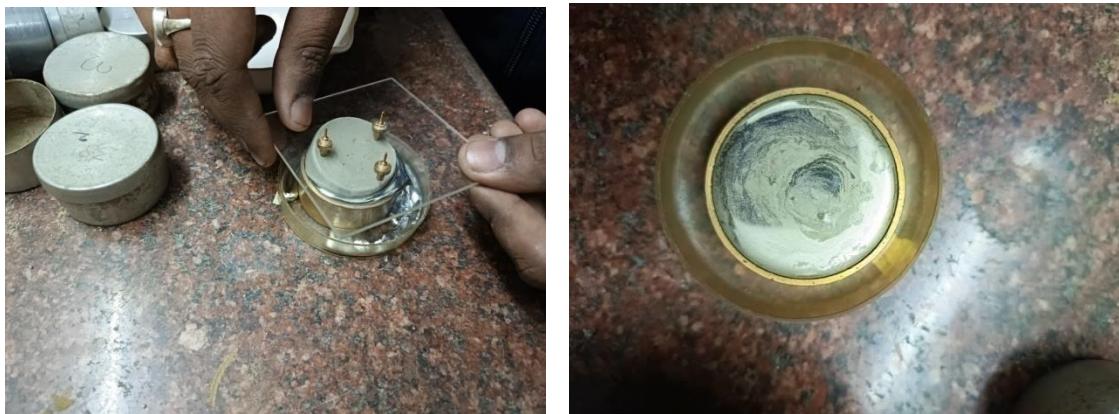
Figure 34 : Shrinkage Limit Test by Mercury Displacement Method

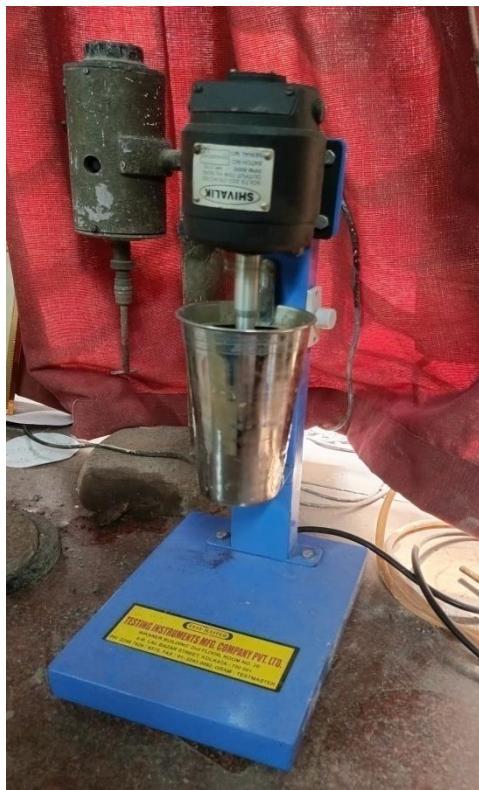
Test Procedure: The hydrometer analysis involves dispersing a finegrained soil sample in a dispersing agent solution (sodium hexametaphosphate). The soil suspension is then transferred into a graduated cylinder filled with distilled water. The suspension is stirred, and the hydrometer is placed in the cylinder to measure the density of the suspension at different time intervals as the particles settle. The readings are corrected for temperature and meniscus errors. The grain size distribution curve is plotted using the hydrometer readings and corresponding particle diameters (IS 2720 (Part 4): 1985).

Figure 35: Stirring apparatus

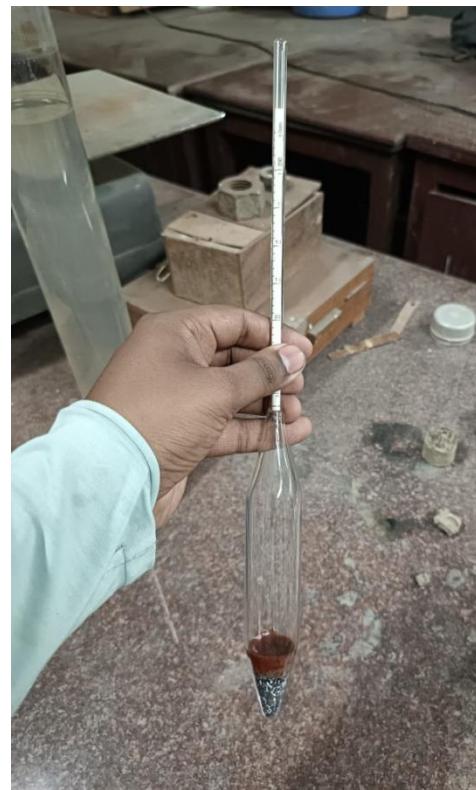
Figure 35: Hydrometer

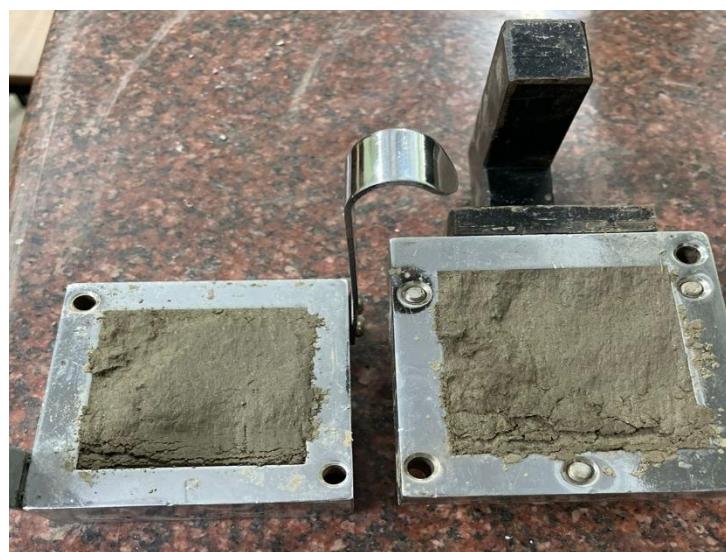
Test Procedure: The soil sample is placed in the shear box, which is then assembled in the direct shear apparatus. A normal load is applied to the sample, and the soil is sheared by moving the top half of the shear box relative to the bottom half. The horizontal displacement and vertical deformation are recorded using dial gauges. The test is conducted at different normal loads to obtain a series of shear strength values, which are then used to plot the MohrCoulomb failure envelope (IS 2720 (Part 13): 1986).

Figure 37: Shear Box

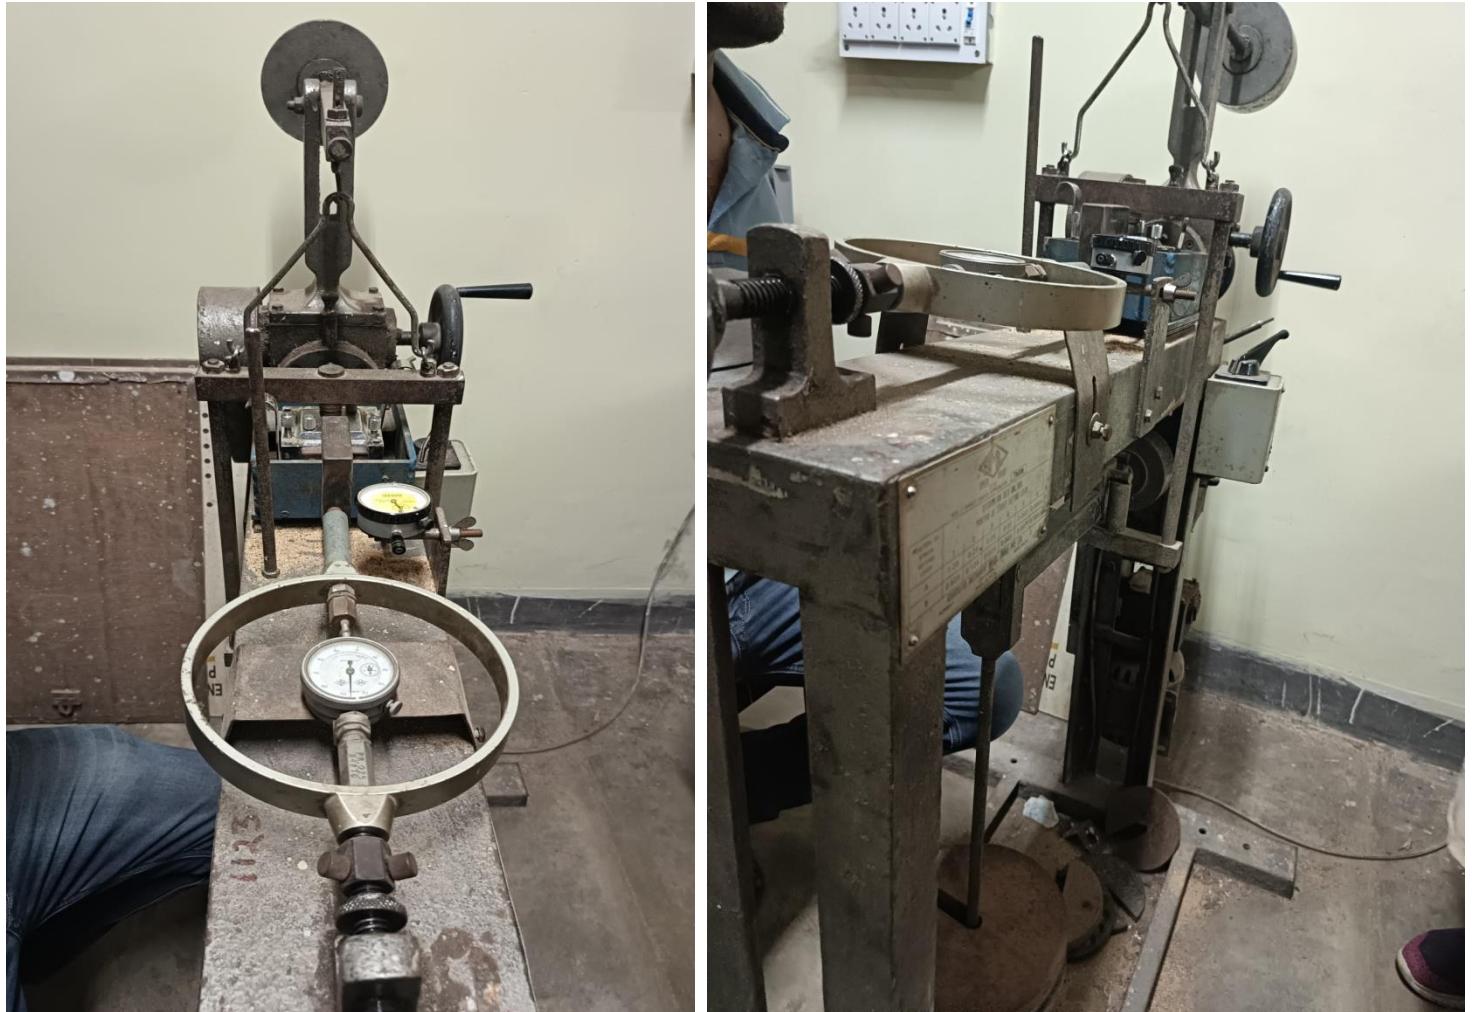
Data Collection: Horizontal displacement, vertical deformation, and the corresponding shear force are recorded during the test. The shear strength parameters are calculated from the failure envelope plotted using these values

Figure 38 : Direct Shear apparatus
